## **Summary of an Investigation into the Condition of Grafted Beech in North Yorkshire.**

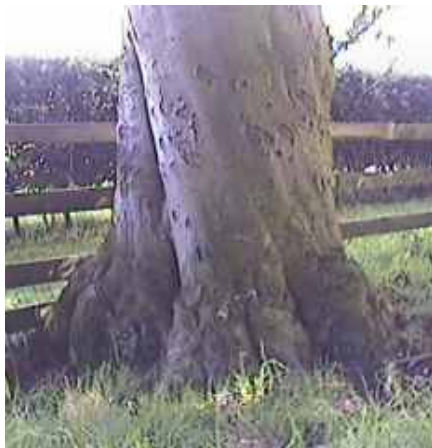
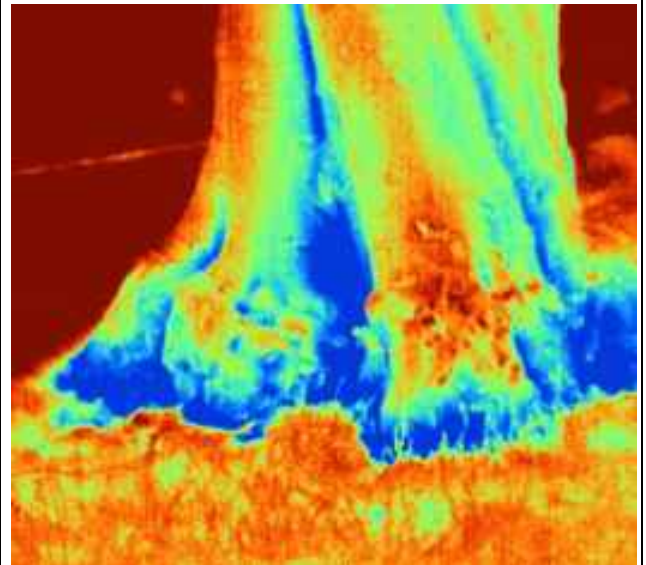
Tree Surveyed	% basal dysfunction	Likelihood of basal failure
Tree 7	60-70	Moderate-high
Tree 8	70-80	High
Tree 9	70-80	High
Tree 10	60-70	Moderate-high
Tree 11	50-60	Moderate

Tree 7: There is some root damage and areas where dysfunction is closer to the surface indicated by dark-blue areas at the base and between buttresses but there are some signs of healthy buttressing indicated by red-orange colours.

Given the amount of temperature depression it was highly likely that there was decay associated with the dysfunction and so following the analysis of the thermal images an increment core sample was taken from the very base of tree 7. Once the increment corer was inserted about 10 cm it could be pushed freely into the centre of the tree, unfortunately this also meant a core sample could not be extracted. The thickness of the residual wall was comparable with the 30-40% expected.

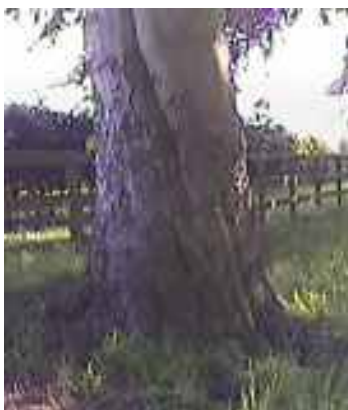
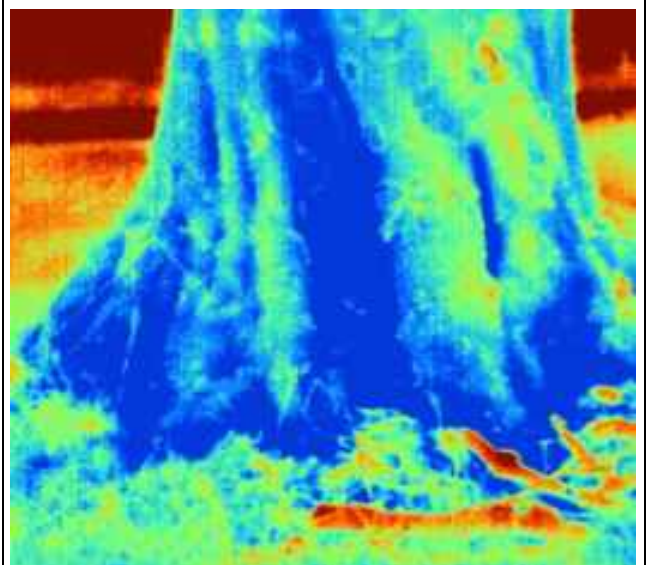
Tree 8: There is extensive root damage indicated by extensive dark-blue areas at the base with few signs of healthy buttressing.

On much closer inspection it was obvious that the original root stock had degenerated; almost completely in the case of tree 8. This had been replaced by the stem tissue above the graft creating a new root system; hence the graft zone had the appearance of having sunk below the soils level in places. A detailed appraisal of the vigour of the trees in relation to the size of the canopy and their location is being undertaken.

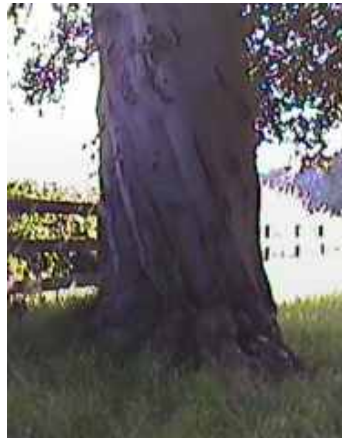
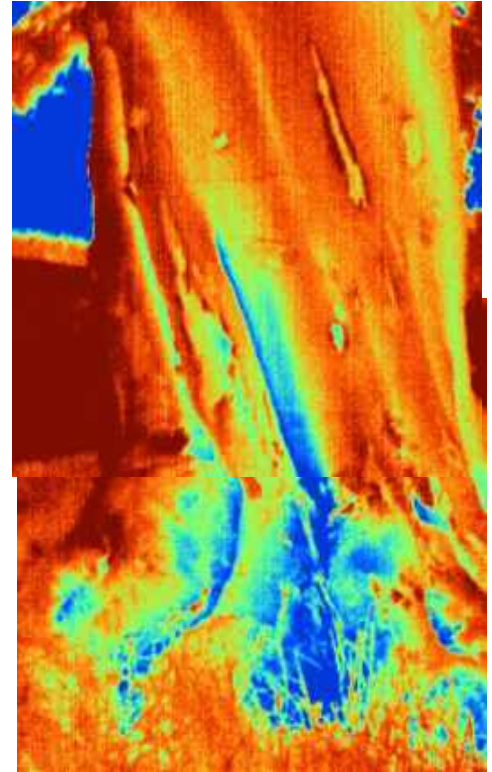
Tree 11: There is some root damage and areas where dysfunction is closer to the surface indicated by dark-blue areas at the base and between buttresses but with healthy buttressing indicated by red-orange colours.
