# Managing Mature Trees

- West Davis Street in Burlington is lined with willow oak trees planted ~80 years ago.
- One tree fell over in a storm, so the City looked at management options.
- 3 trees were removed, and 35 were reduced by specified pruning methods.
- 3 years later, 34 of those trees are doing well. No pruning is needed in the near future.

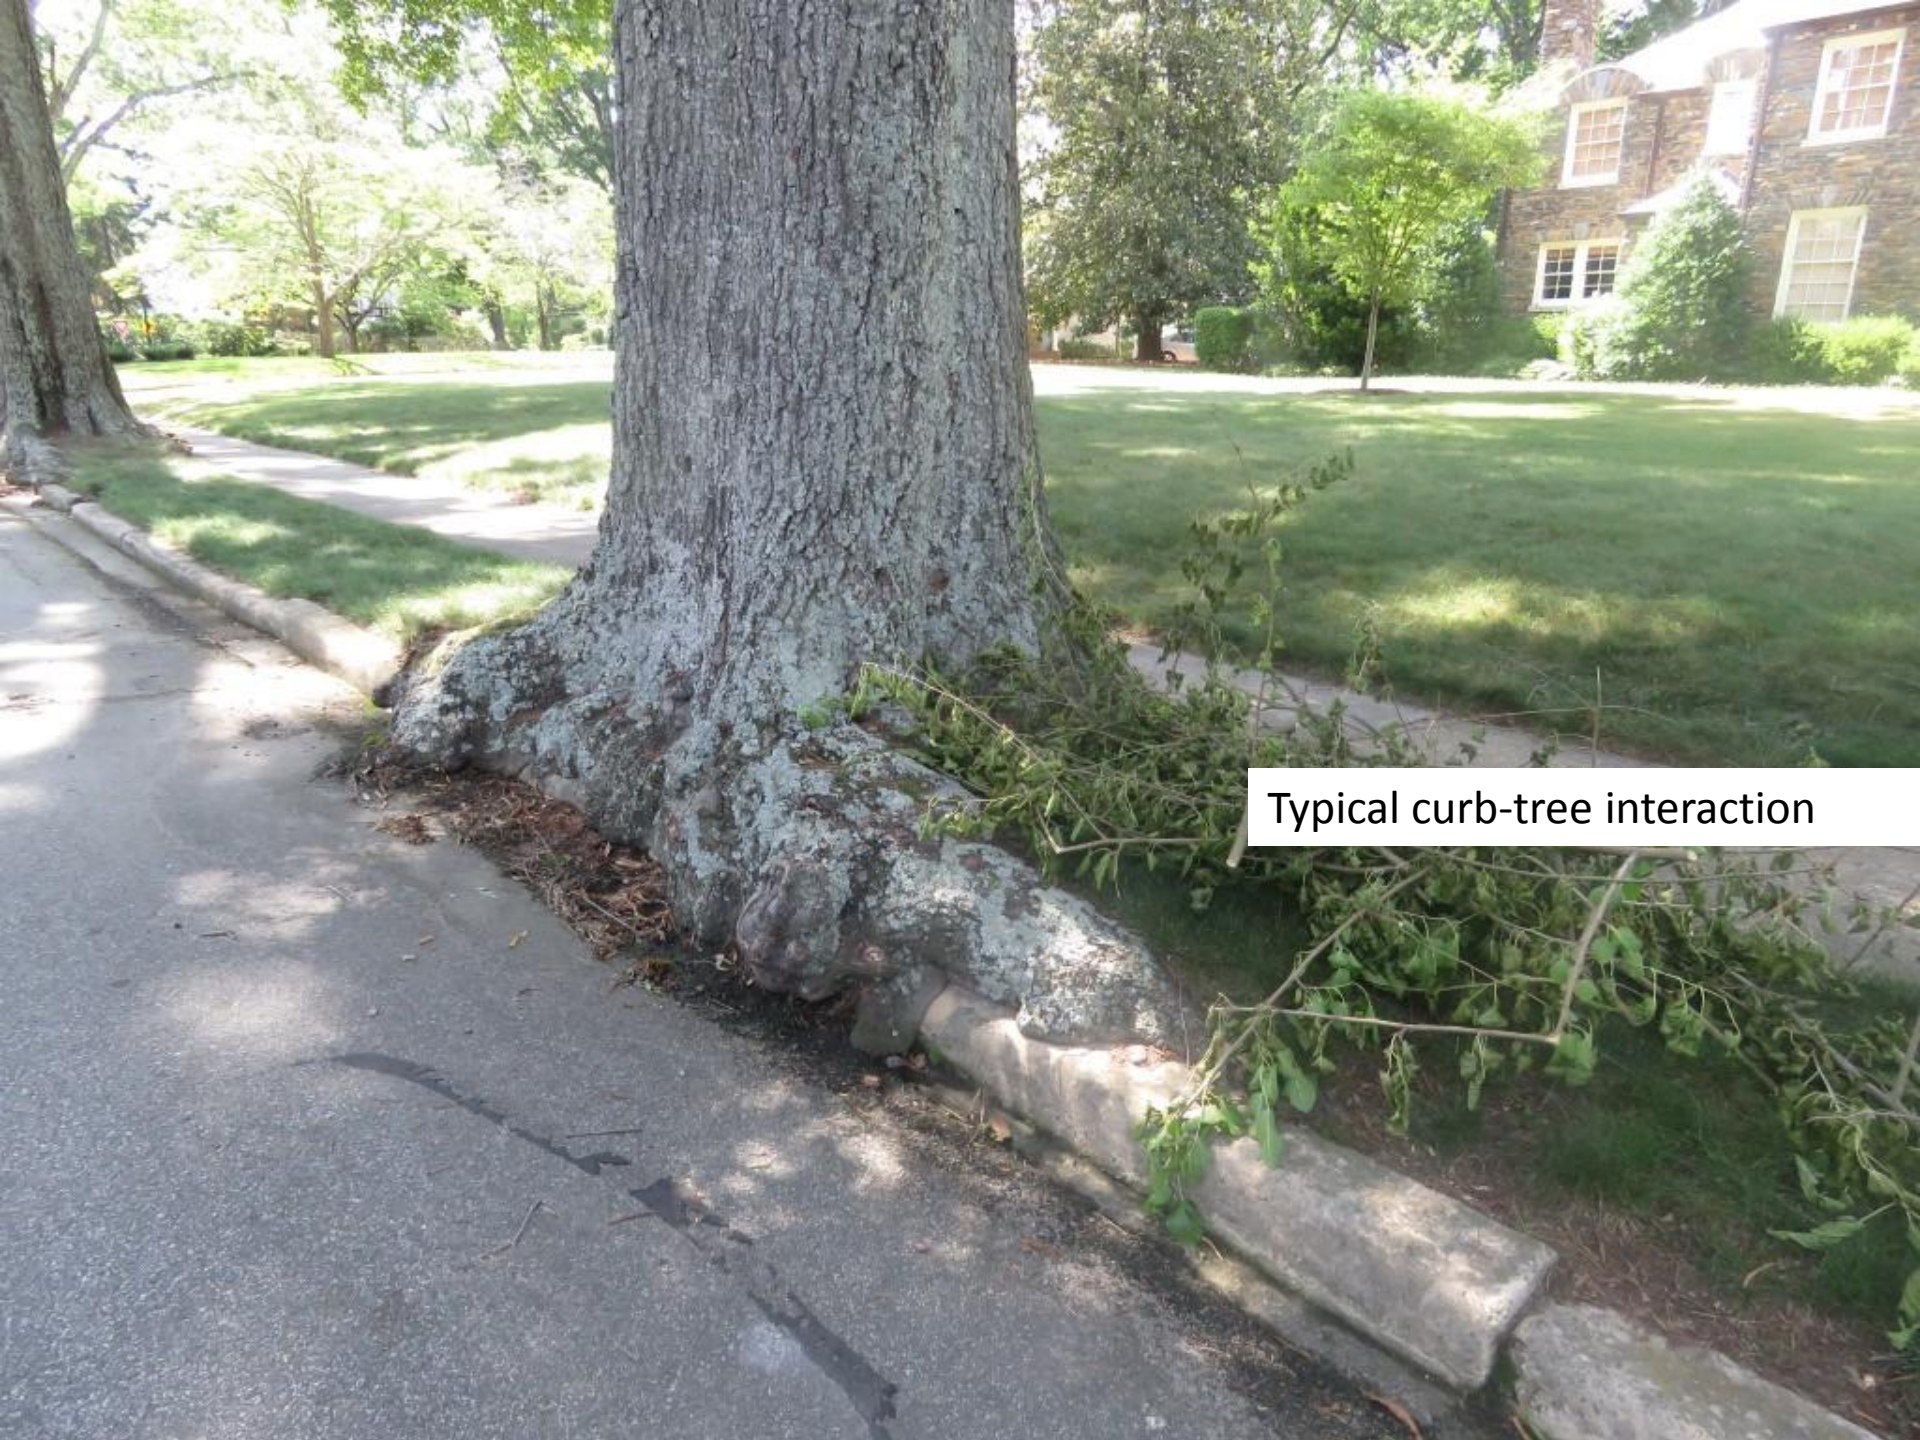
Typical curb-tree interaction

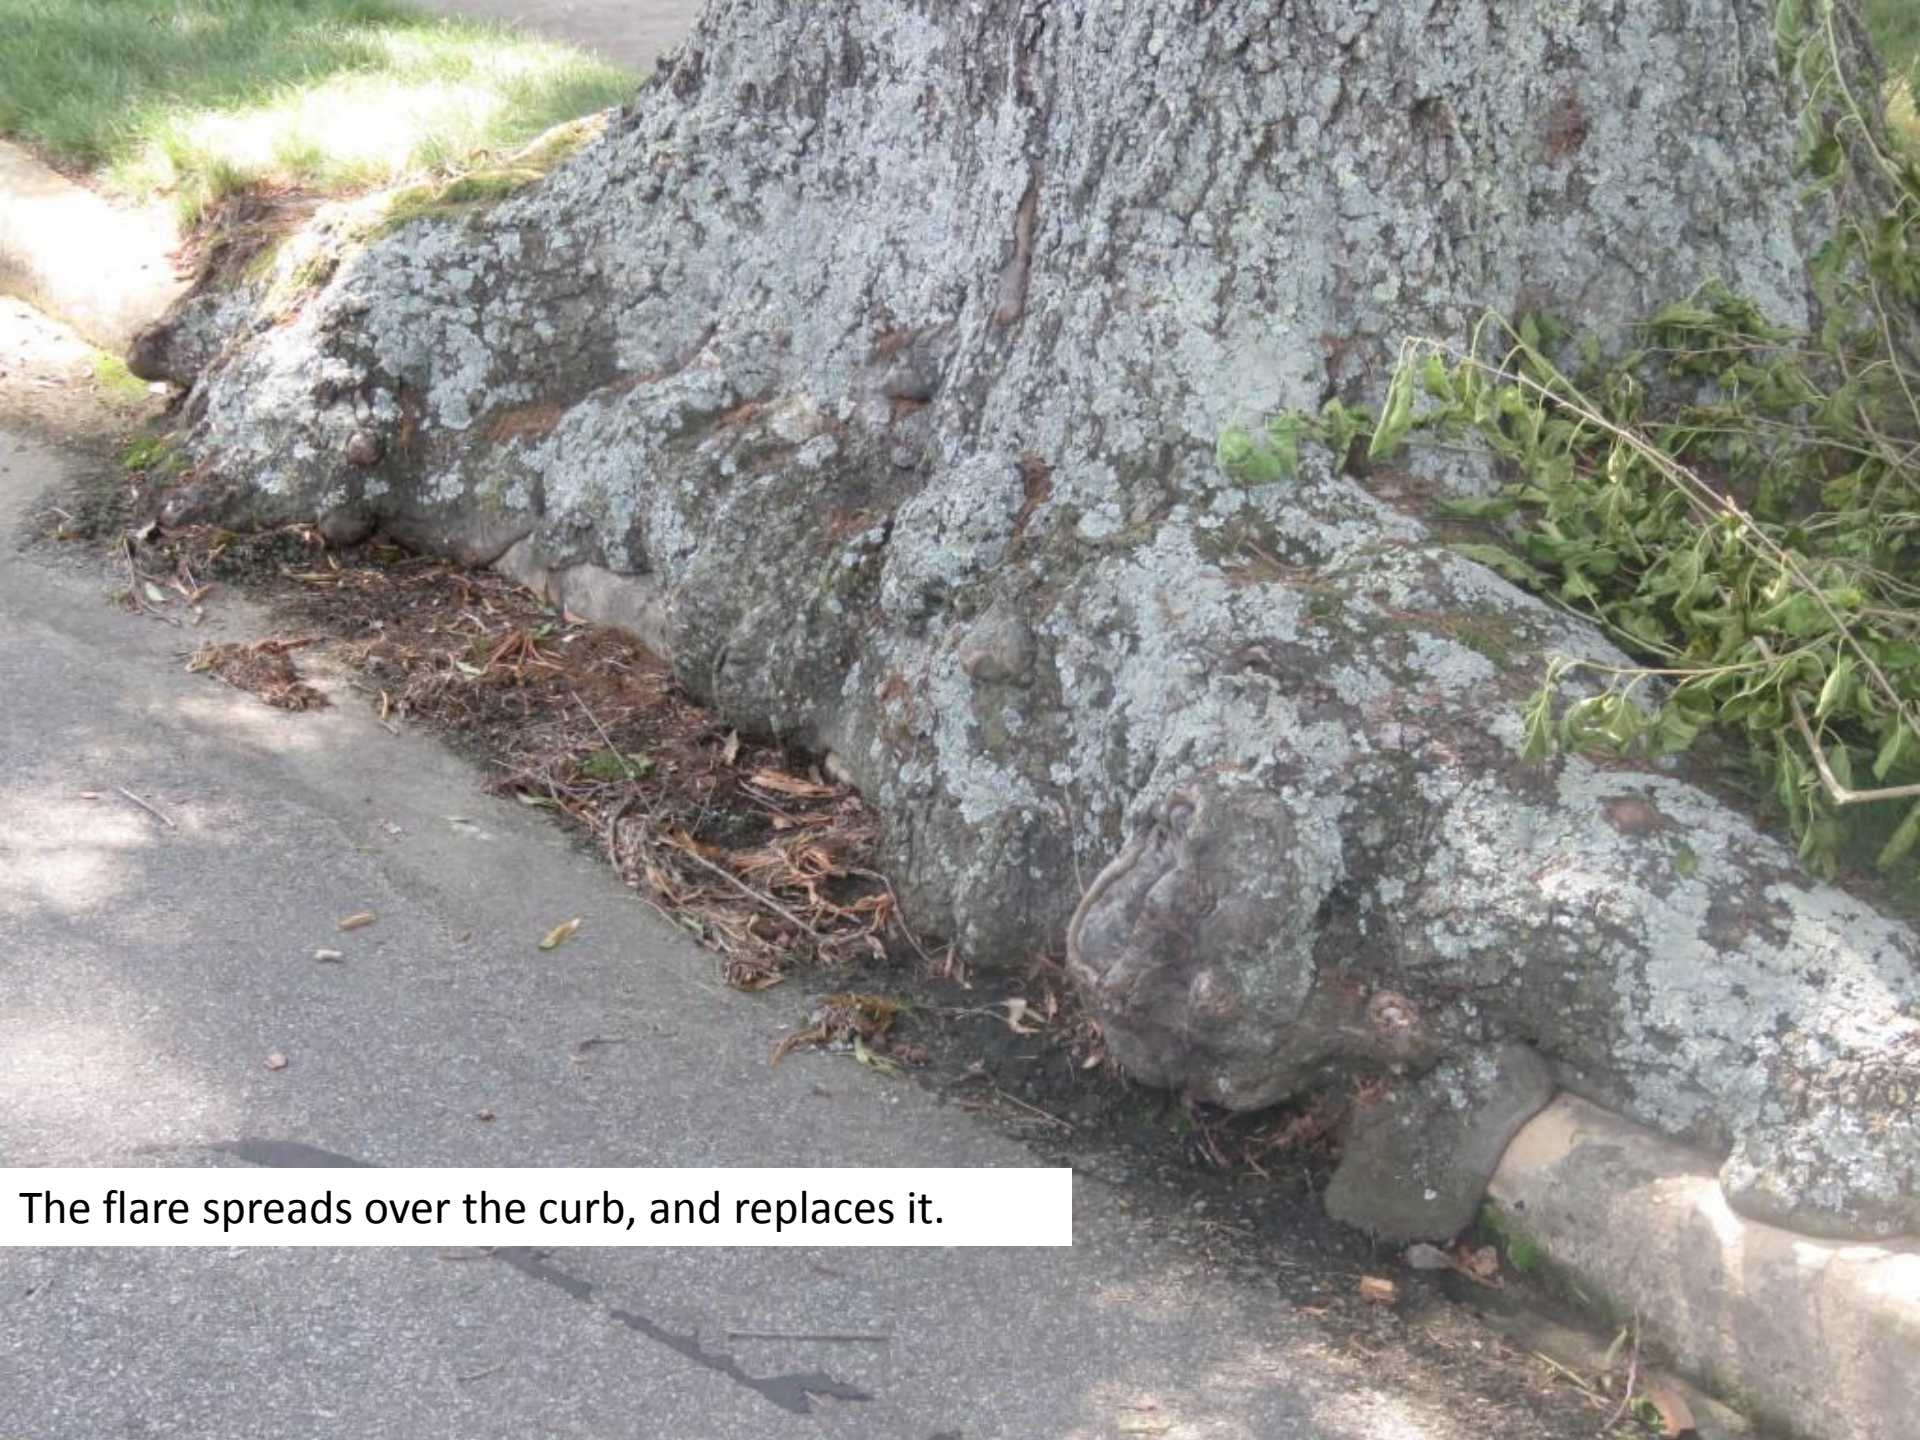
The flare spreads over the curb, and replaces it.

Tire damage is scarred  
over;  
compartmentalized

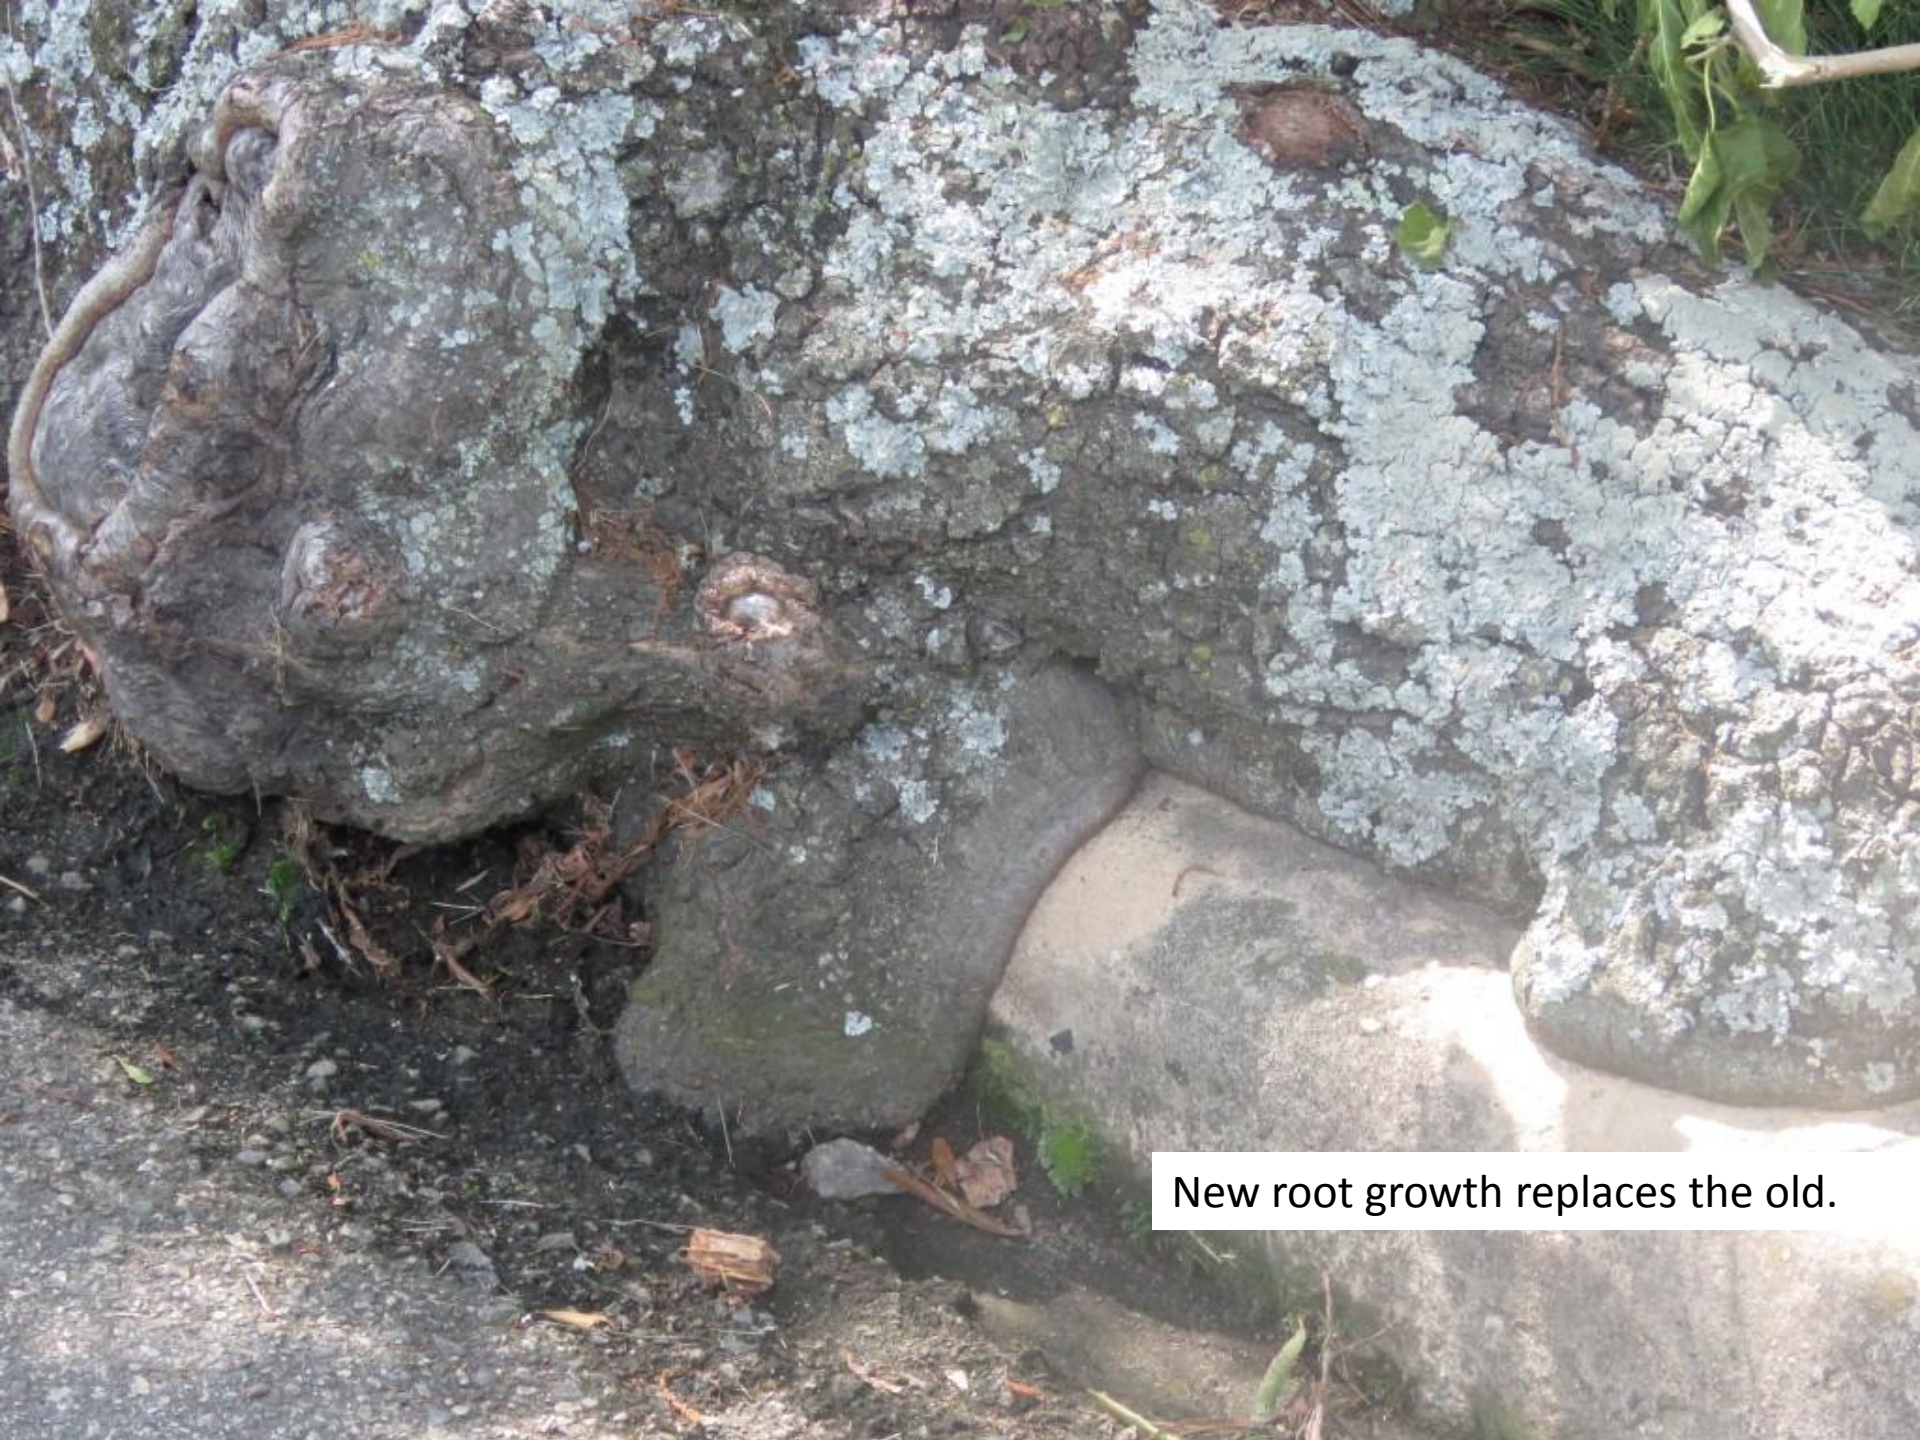
New root growth replaces the old.

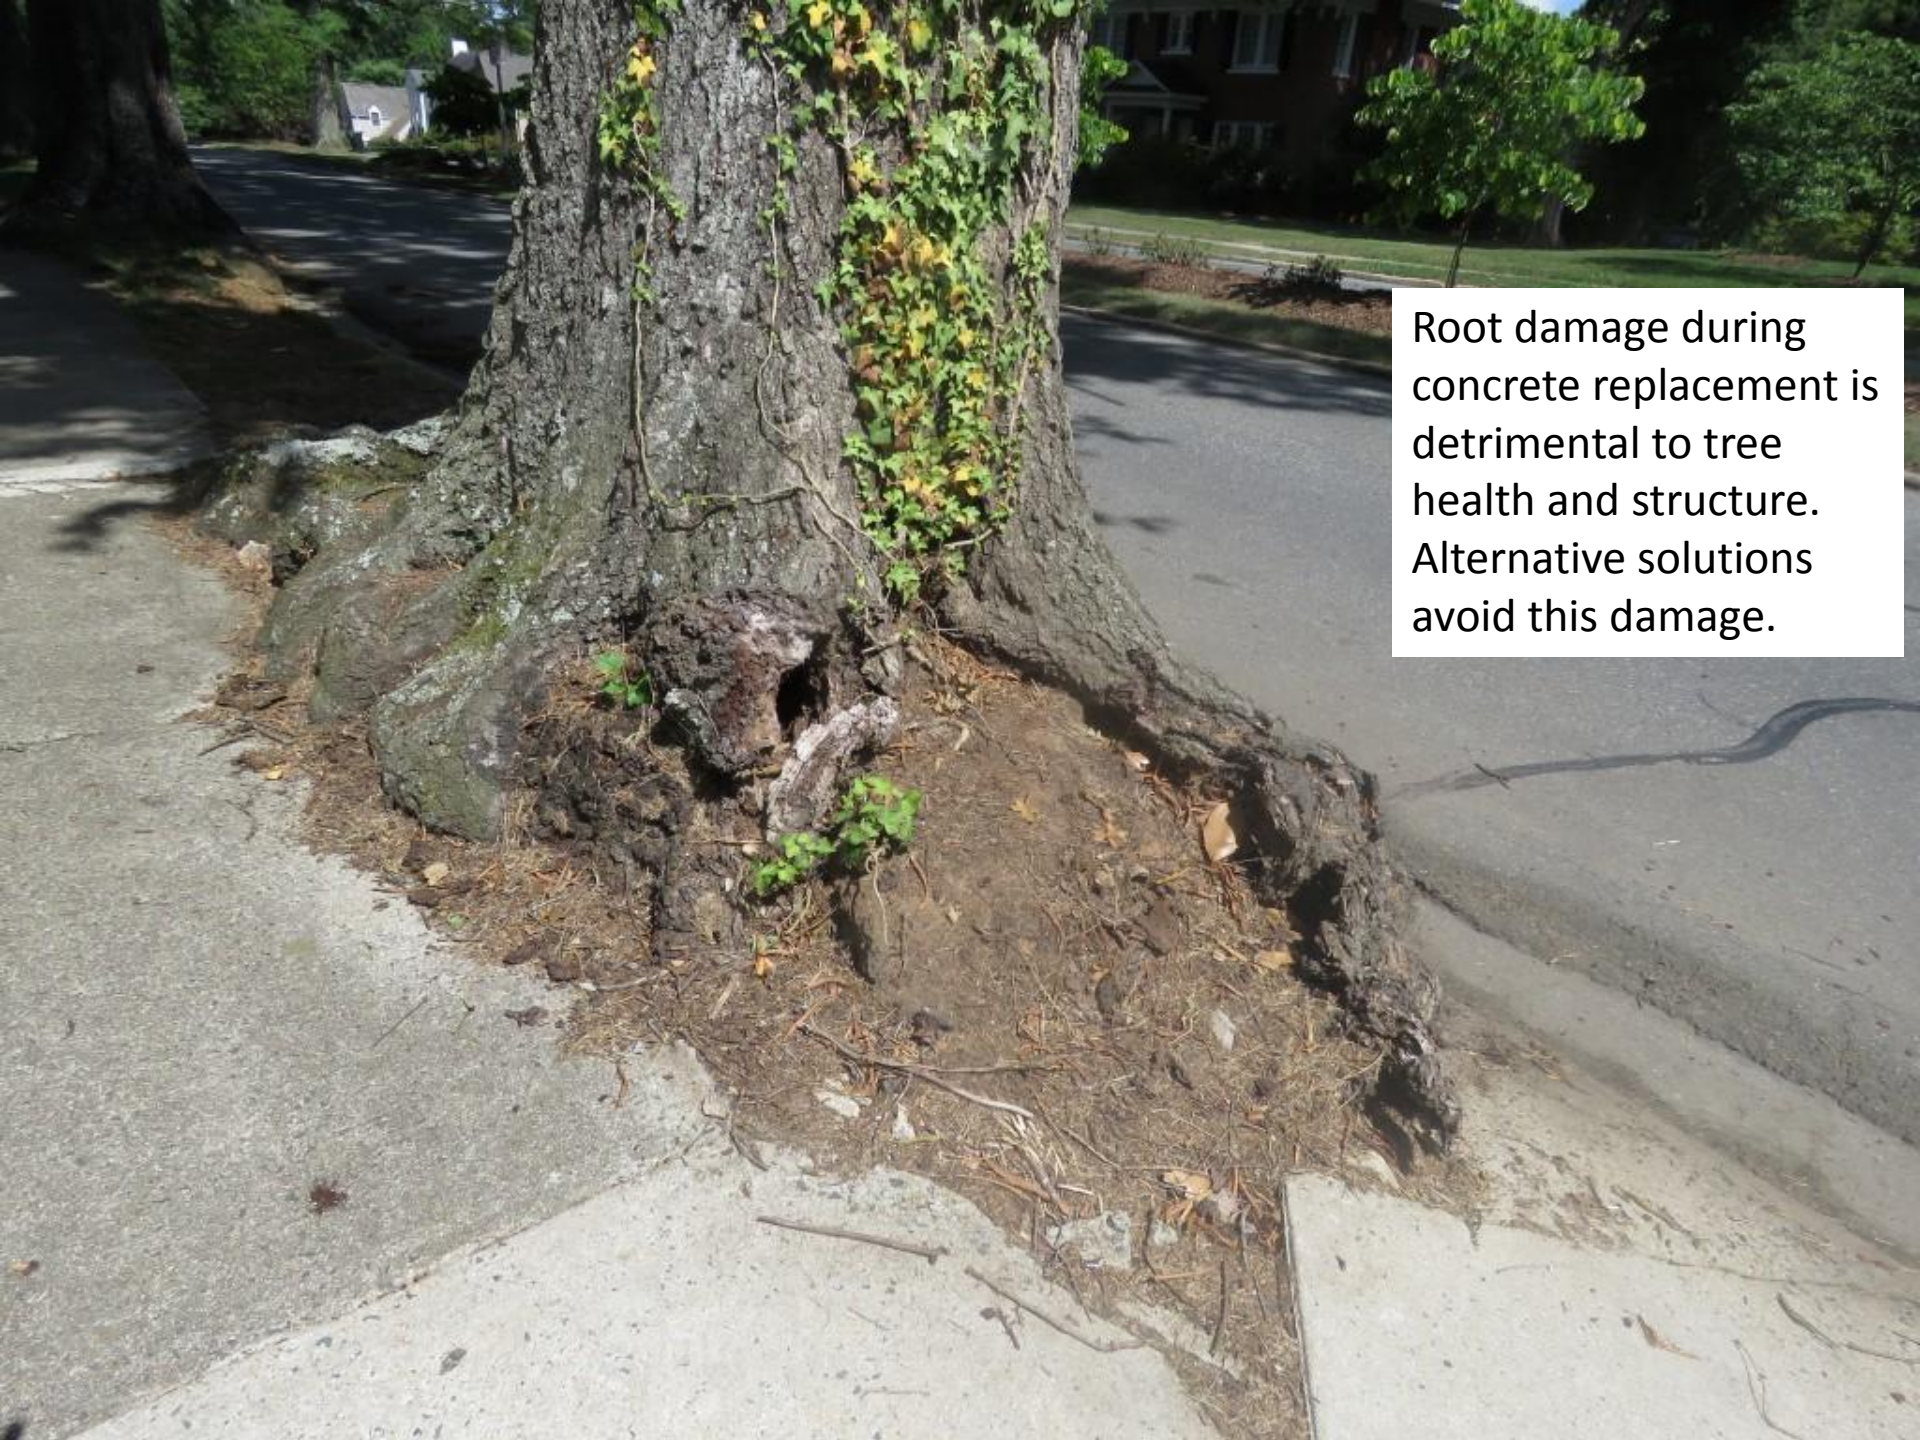
Root damage during concrete replacement is detrimental to tree health and structure. Alternative solutions avoid this damage.

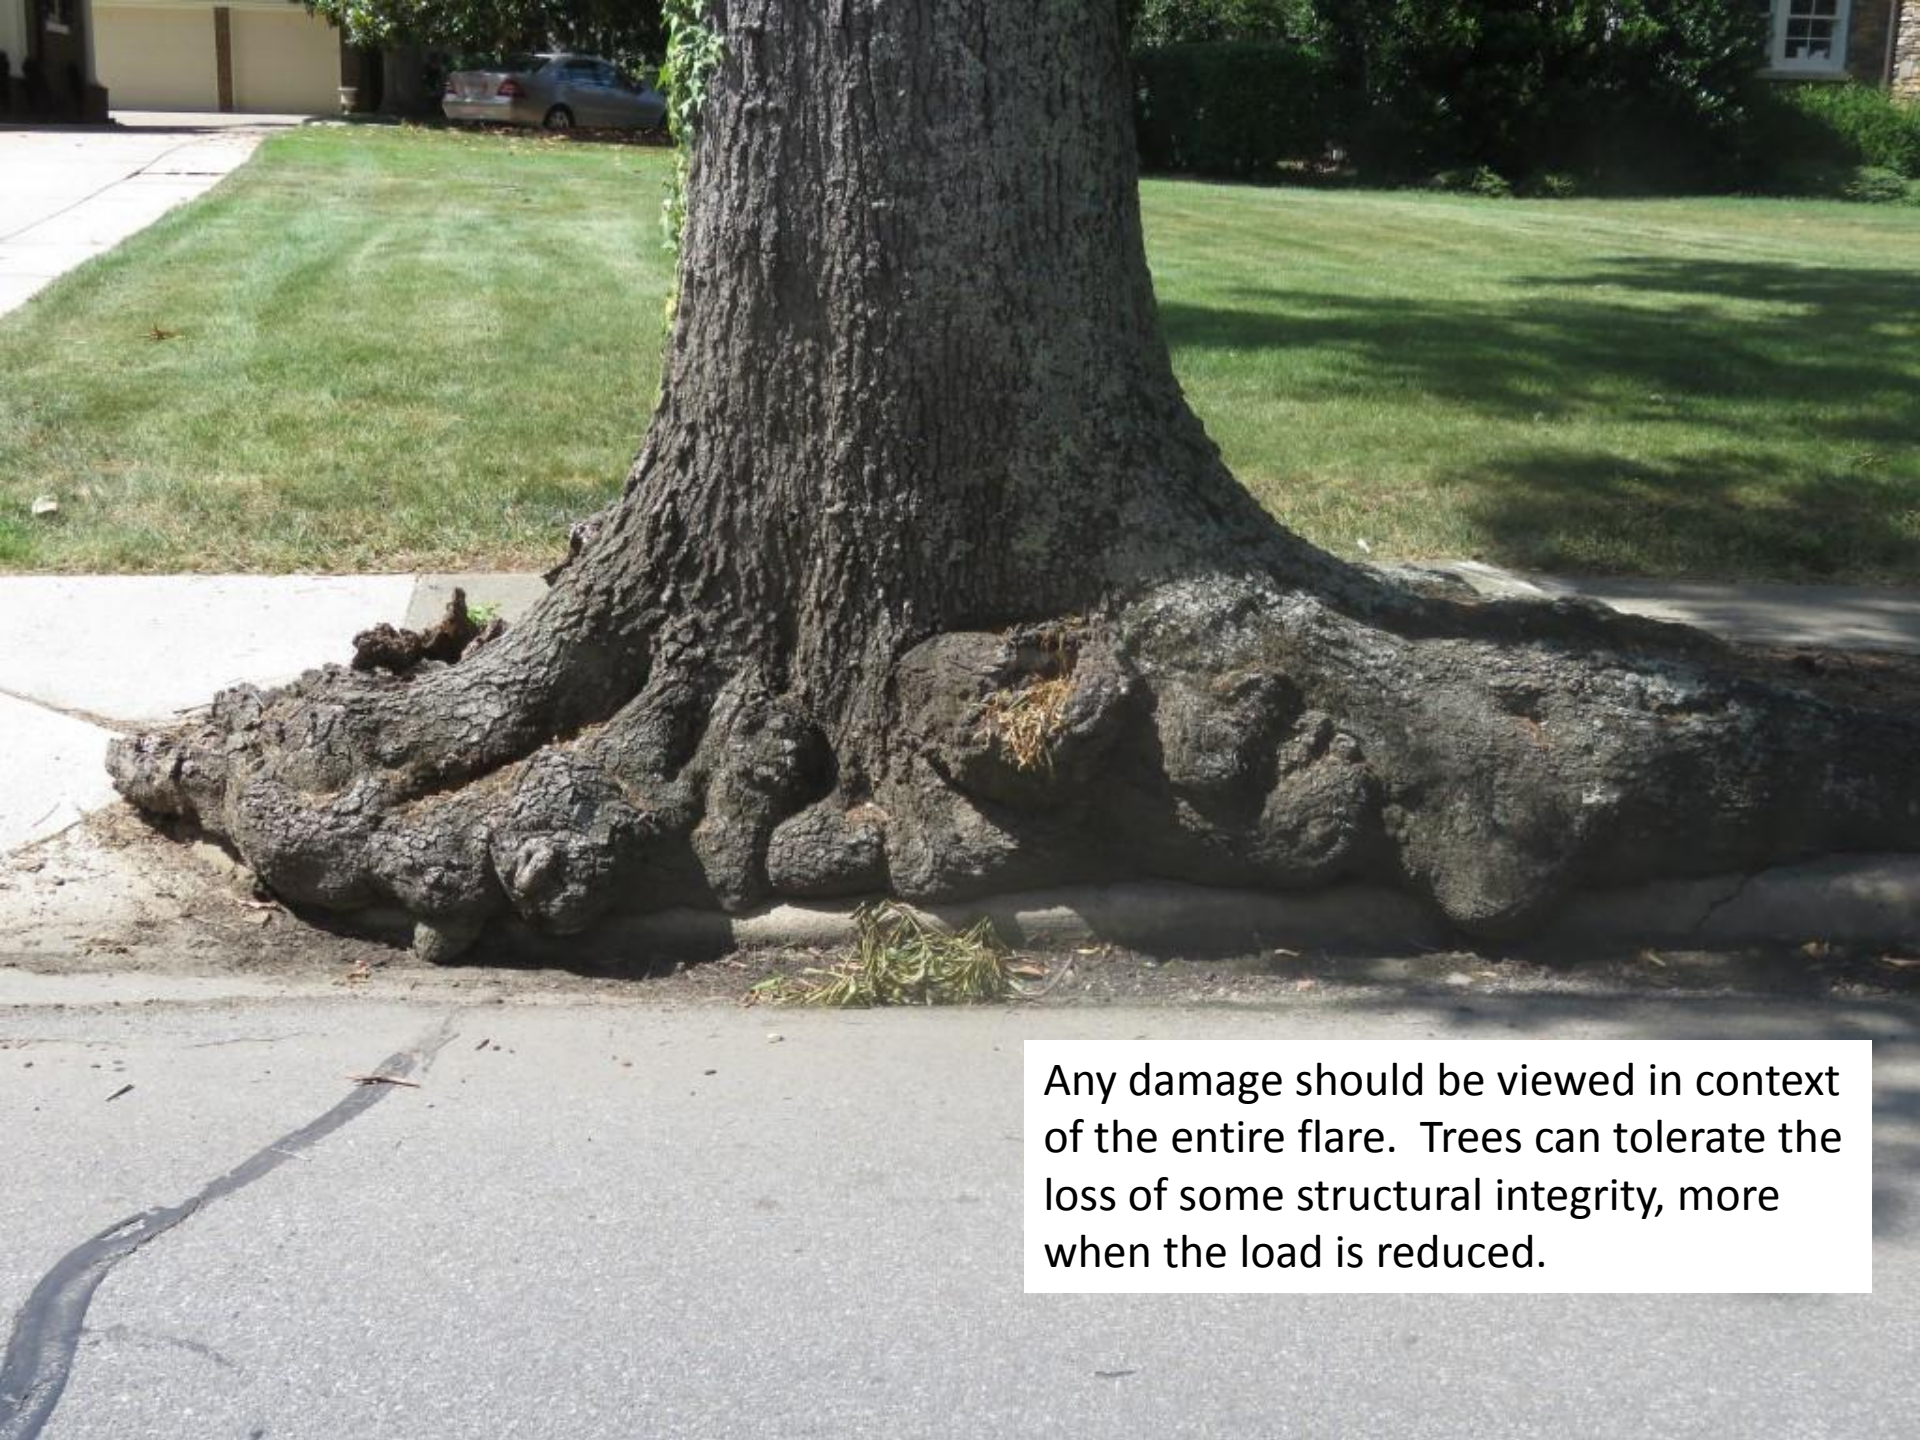
Any damage should be viewed in context of the entire flare. Trees can tolerate the loss of some structural integrity, more when the load is reduced.

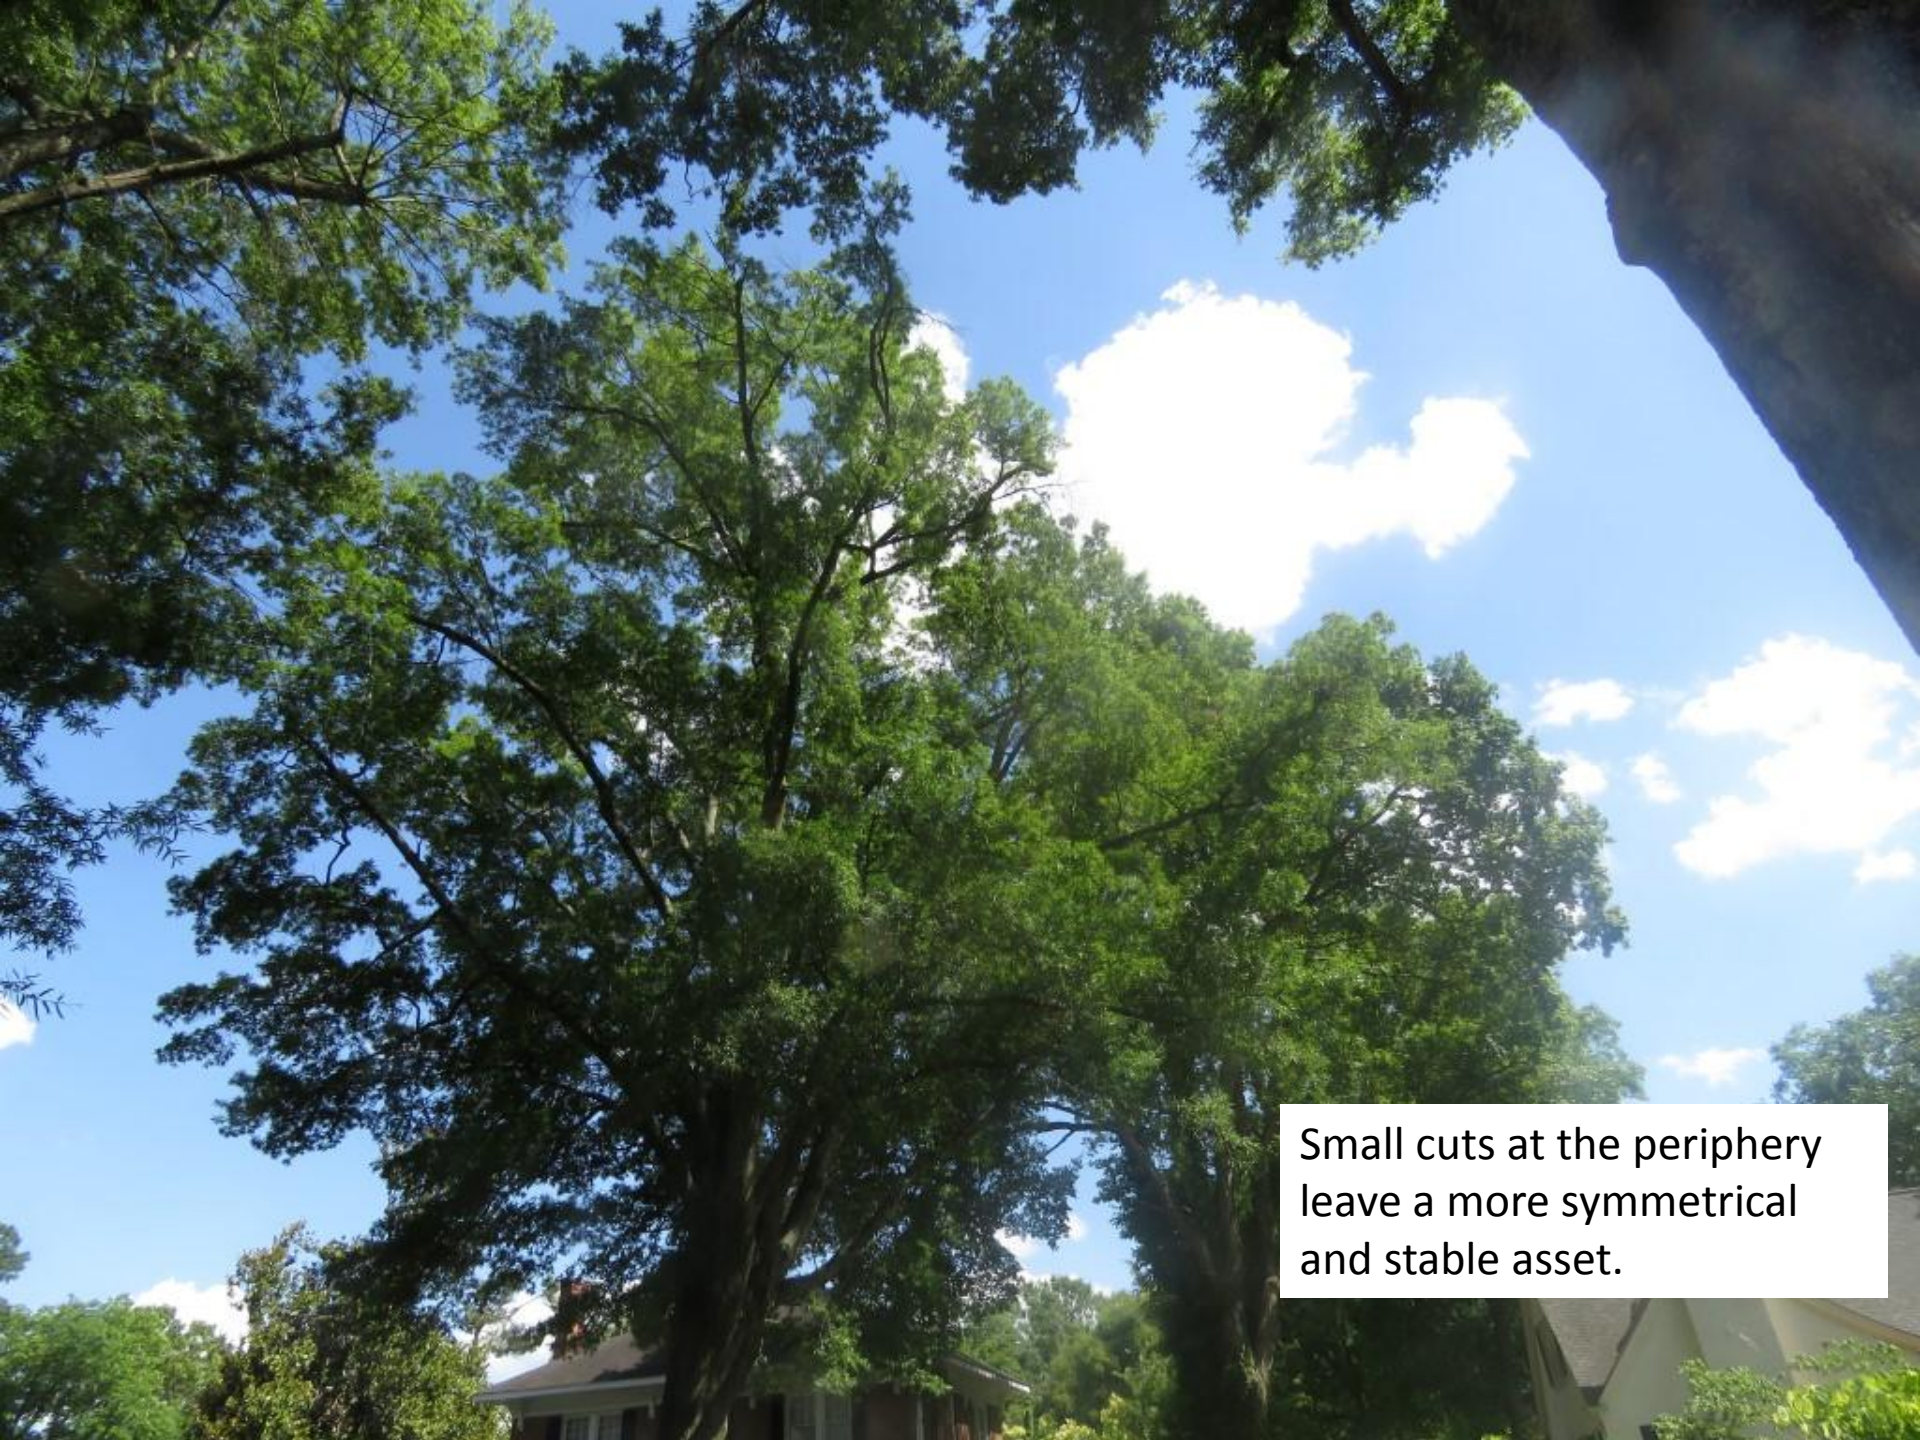
Small cuts at the periphery  
leave a more symmetrical  
and stable asset.

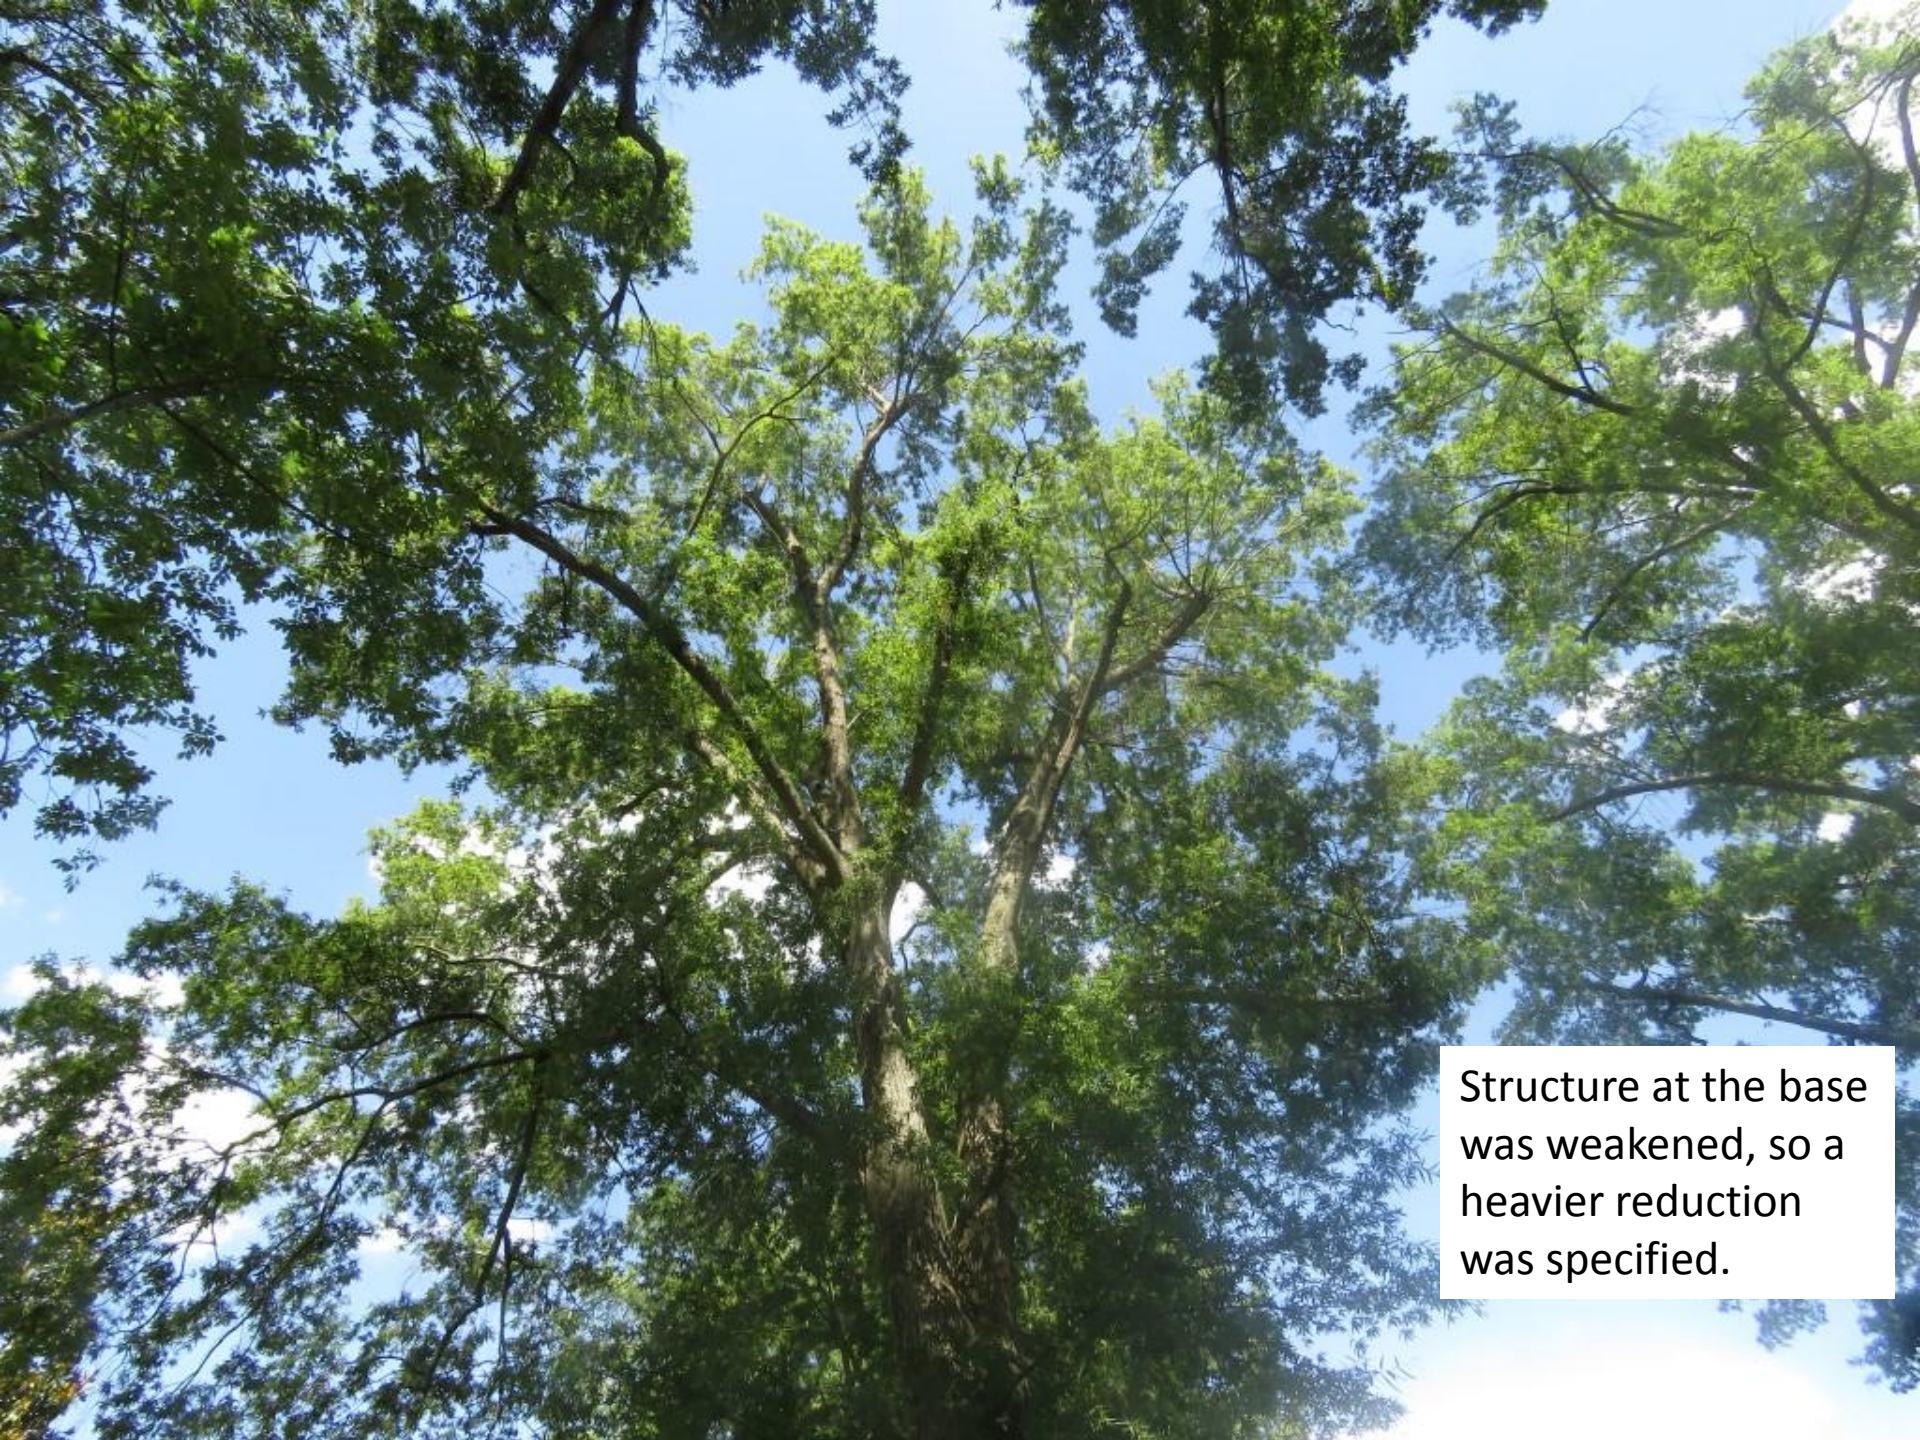
Structure at the base was weakened, so a heavier reduction was specified.

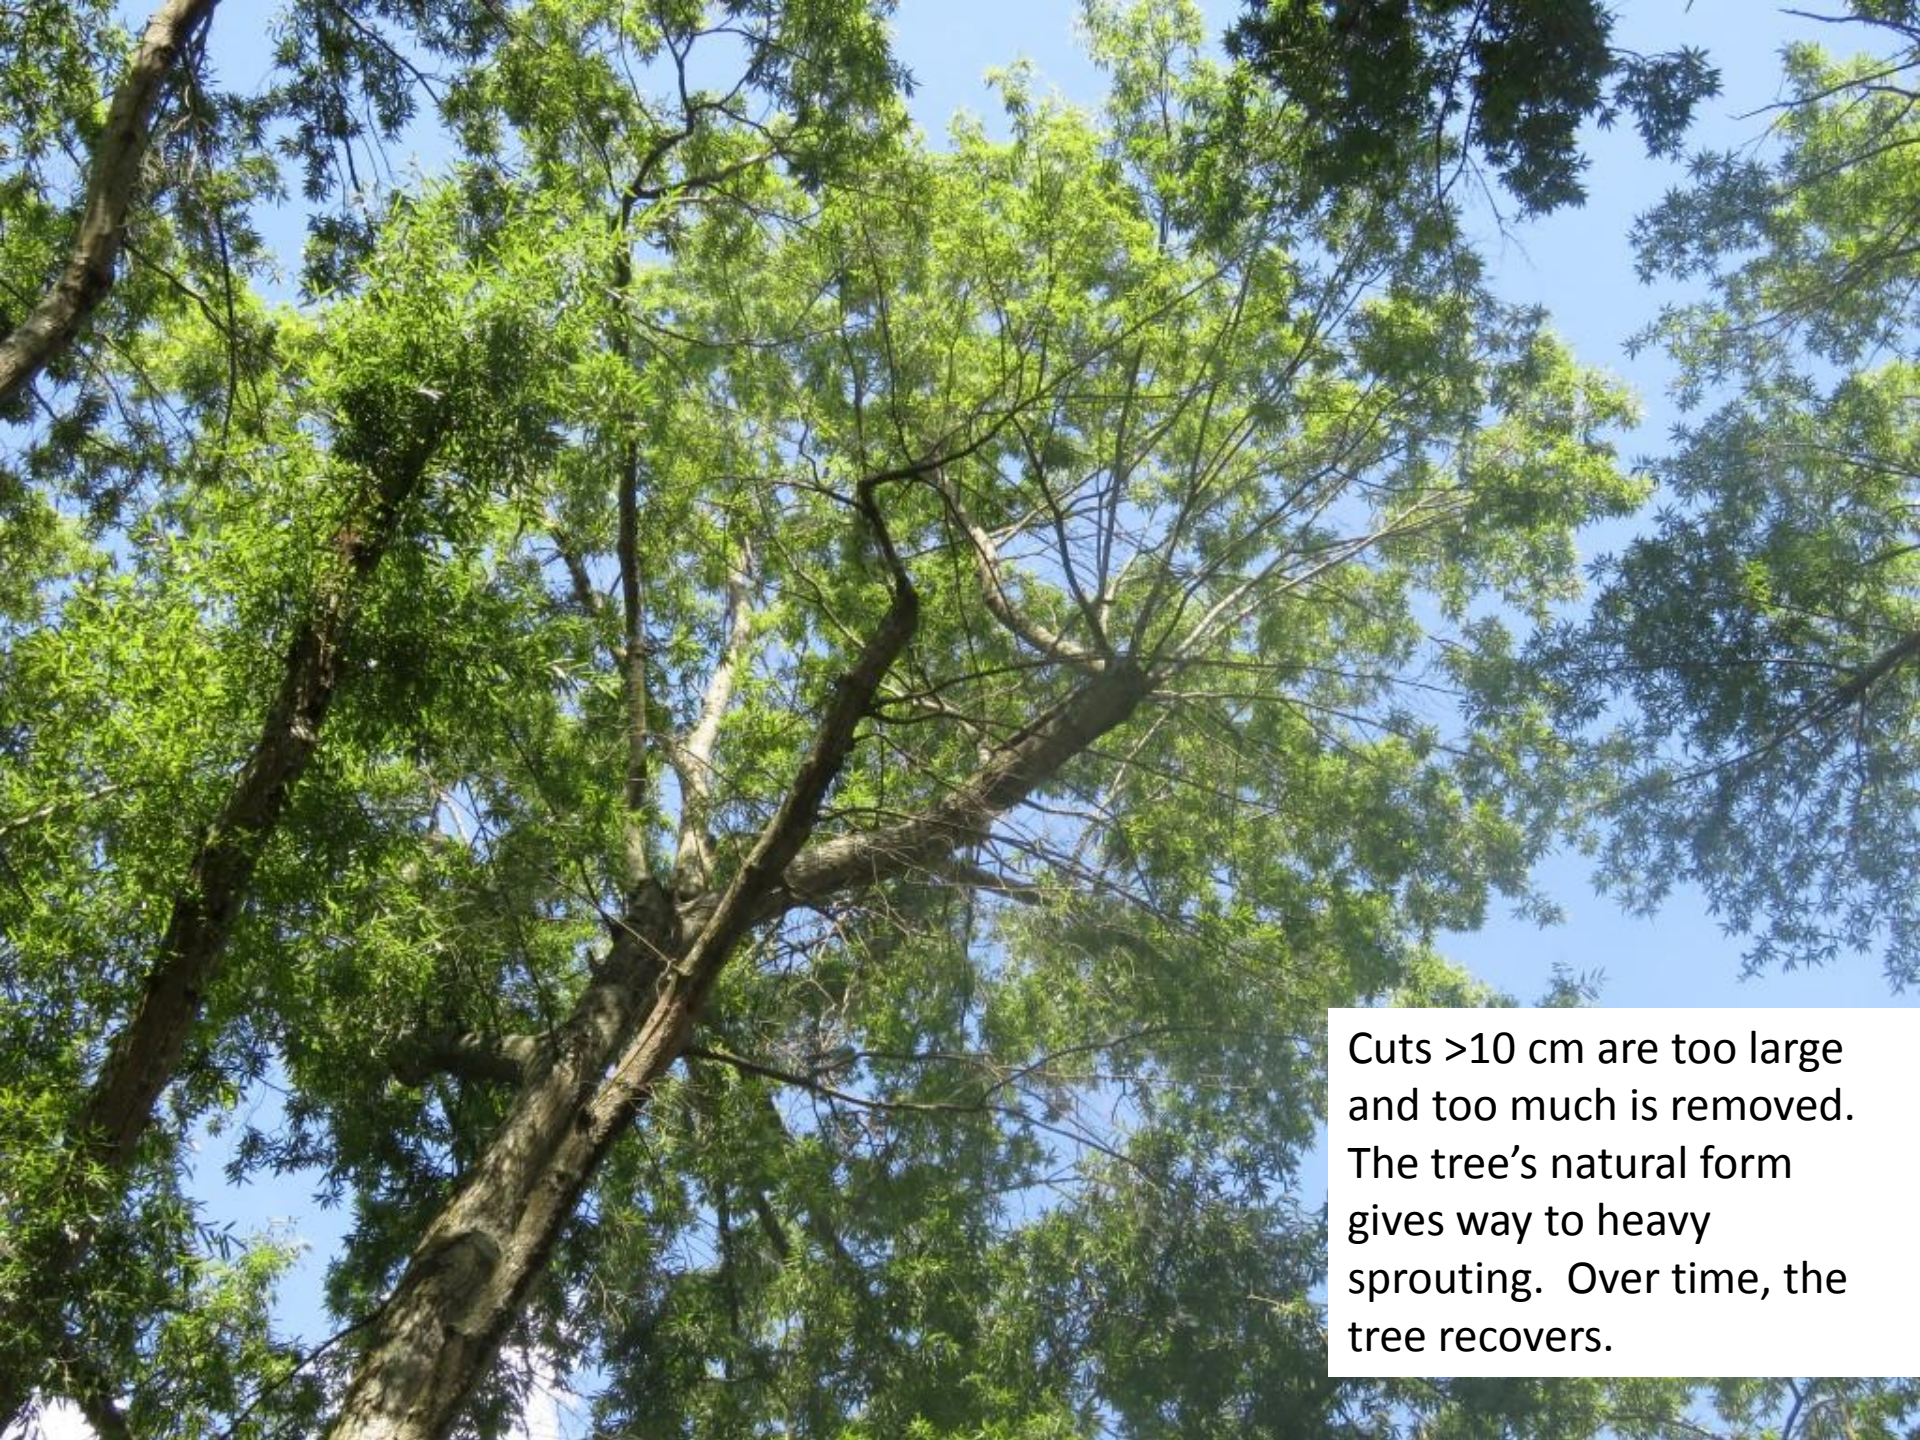
Cuts >10 cm are too large and too much is removed. The tree's natural form gives way to heavy sprouting. Over time, the tree recovers.
