# Managing Mature Trees

- West Davis Street in Burlington is lined with willow oak trees planted ~80 years ago.
- One tree fell over in a storm, so the City looked at management options.
- 3 trees were removed, and 35 were reduced by specified pruning methods.
- 3 years later, 34 of those trees are doing well. No pruning is needed in the near future.

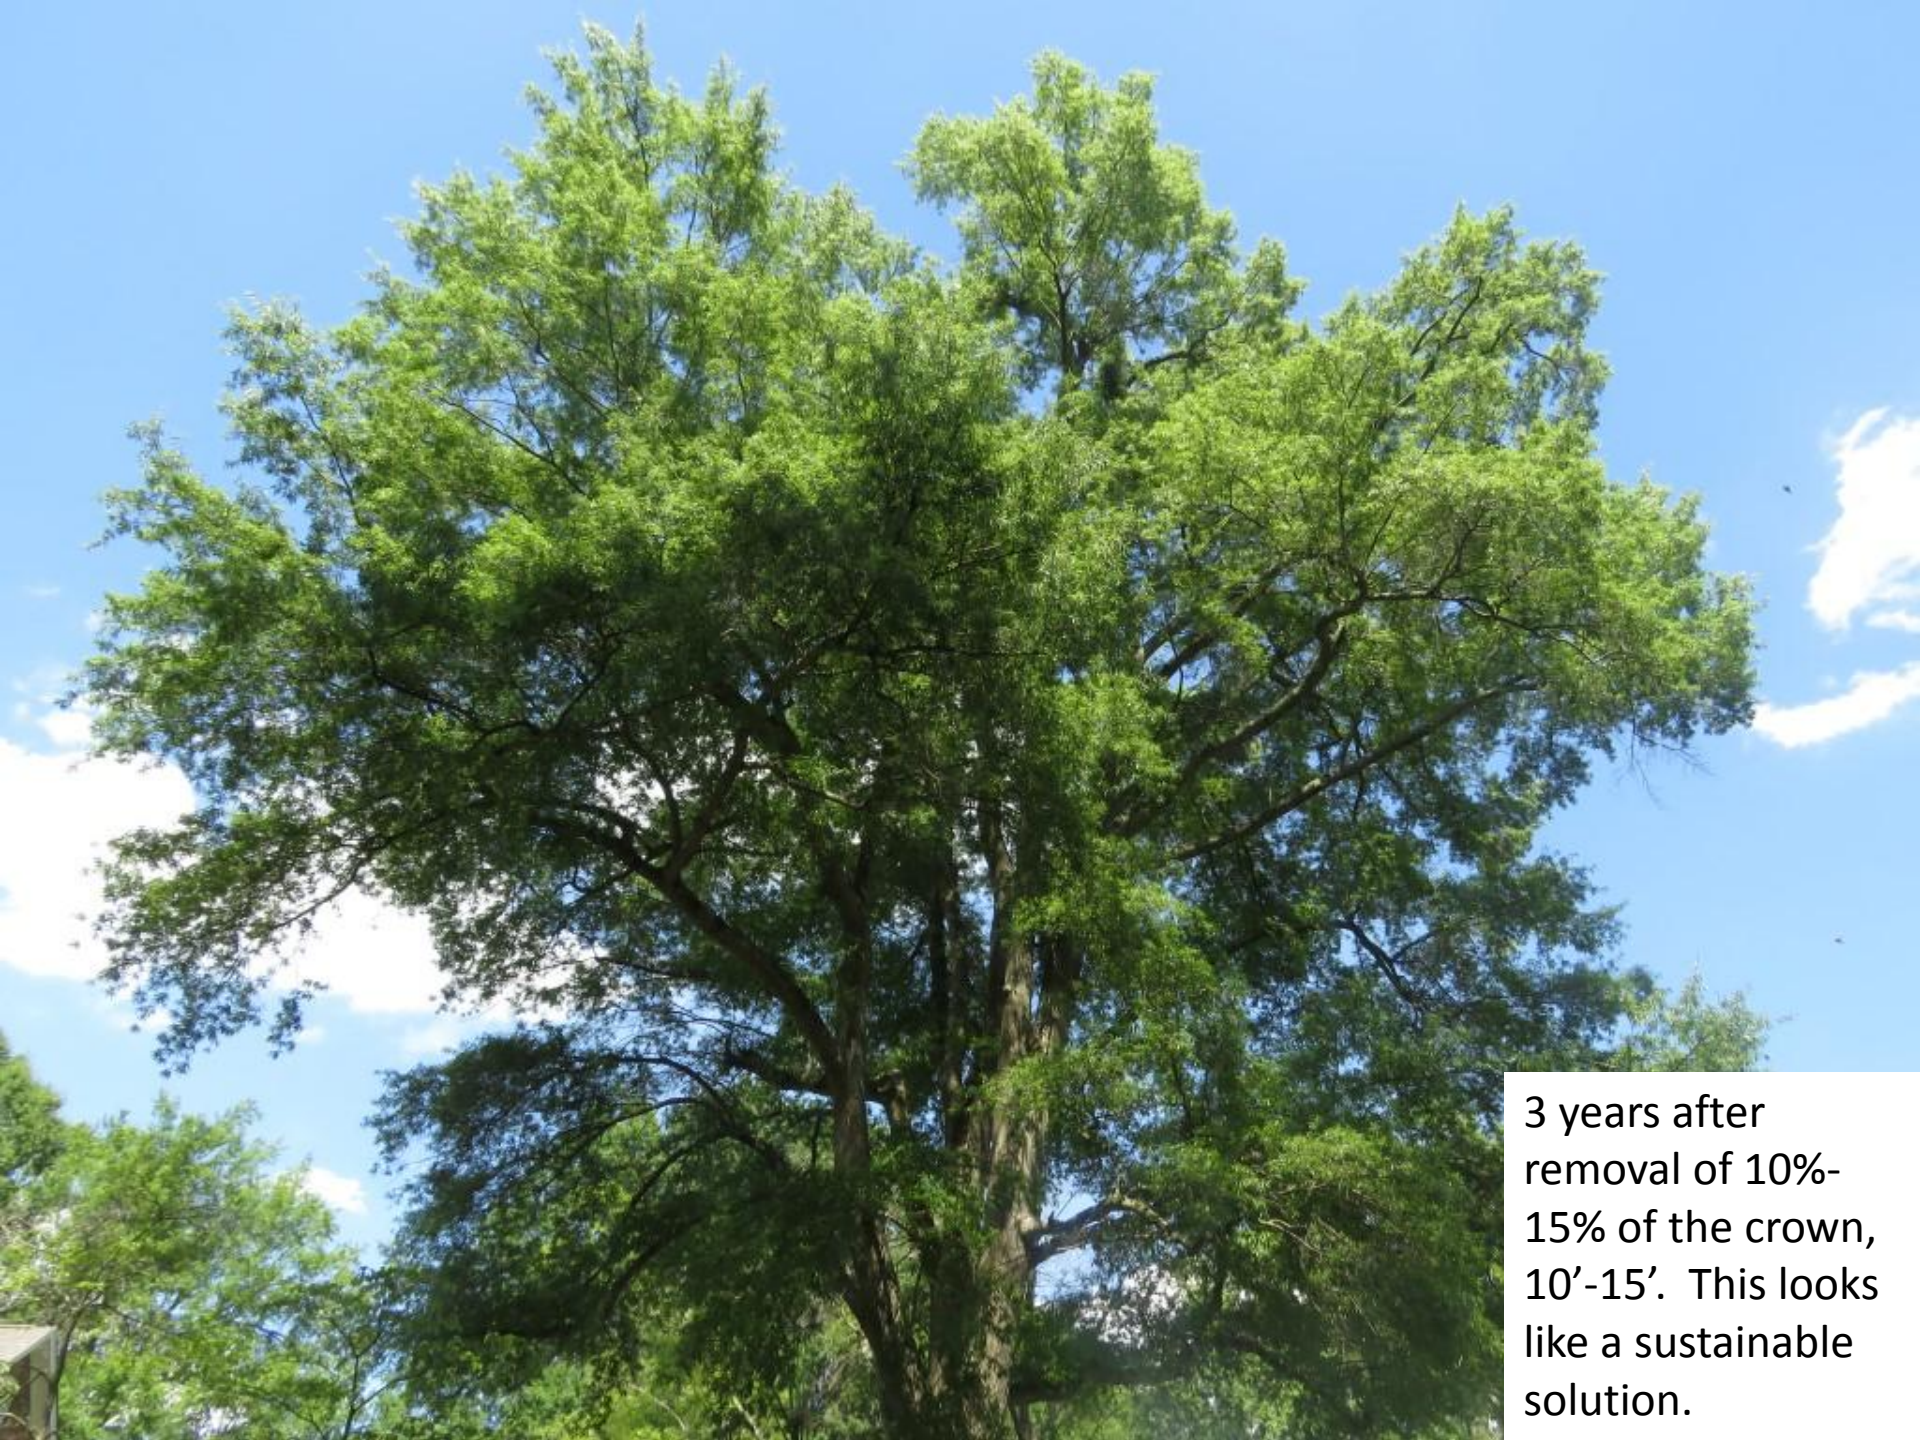
3 years after removal of 10%-15% of the crown, 10'-15'. This looks like a sustainable solution.

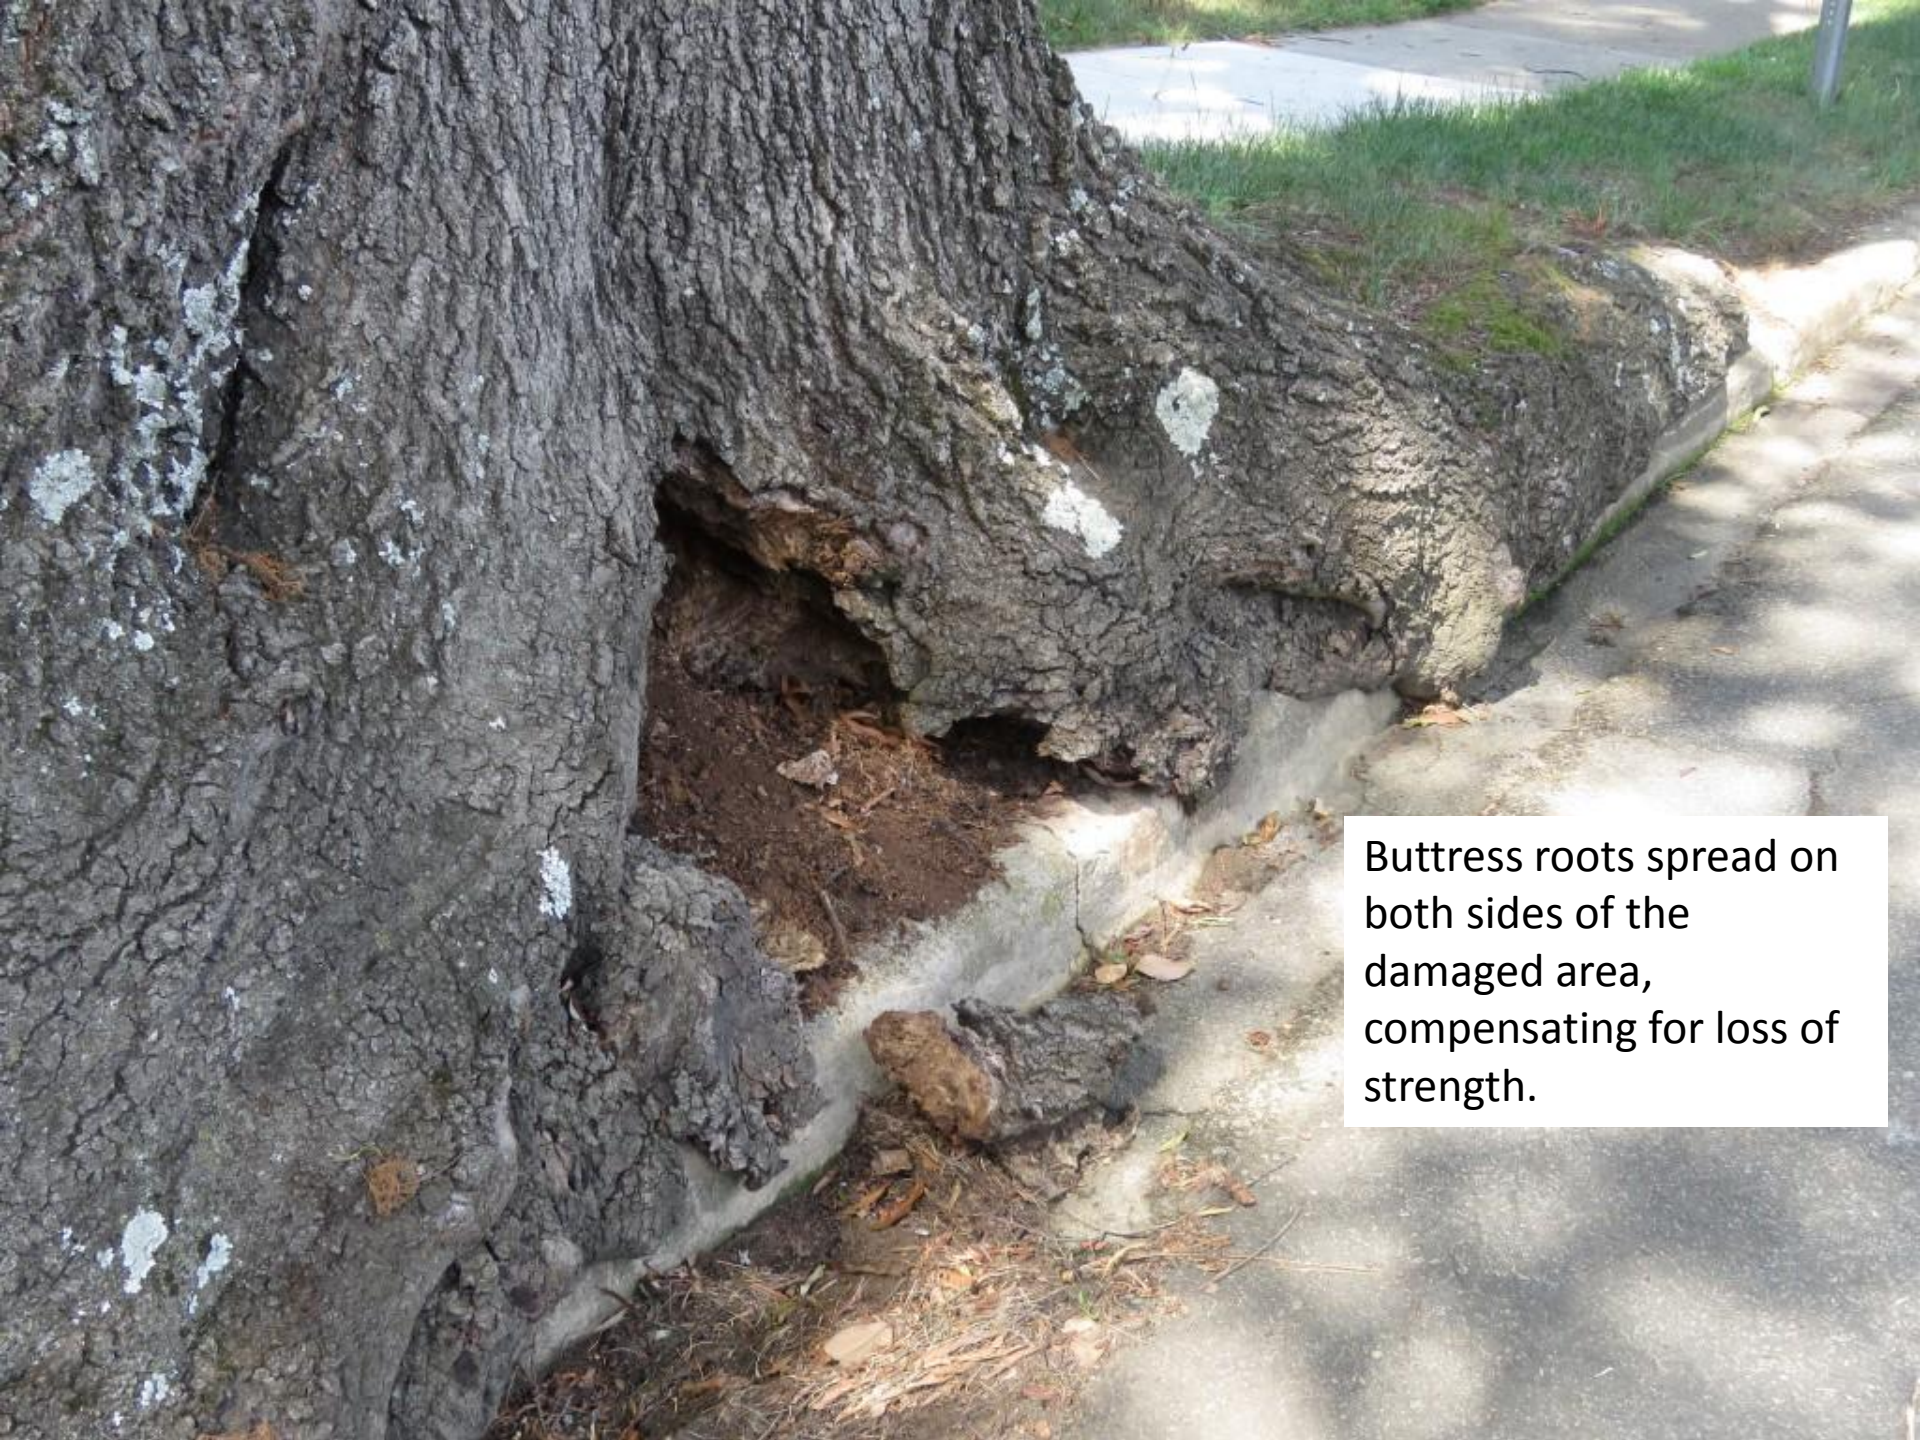
Buttress roots spread on both sides of the damaged area, compensating for loss of strength.

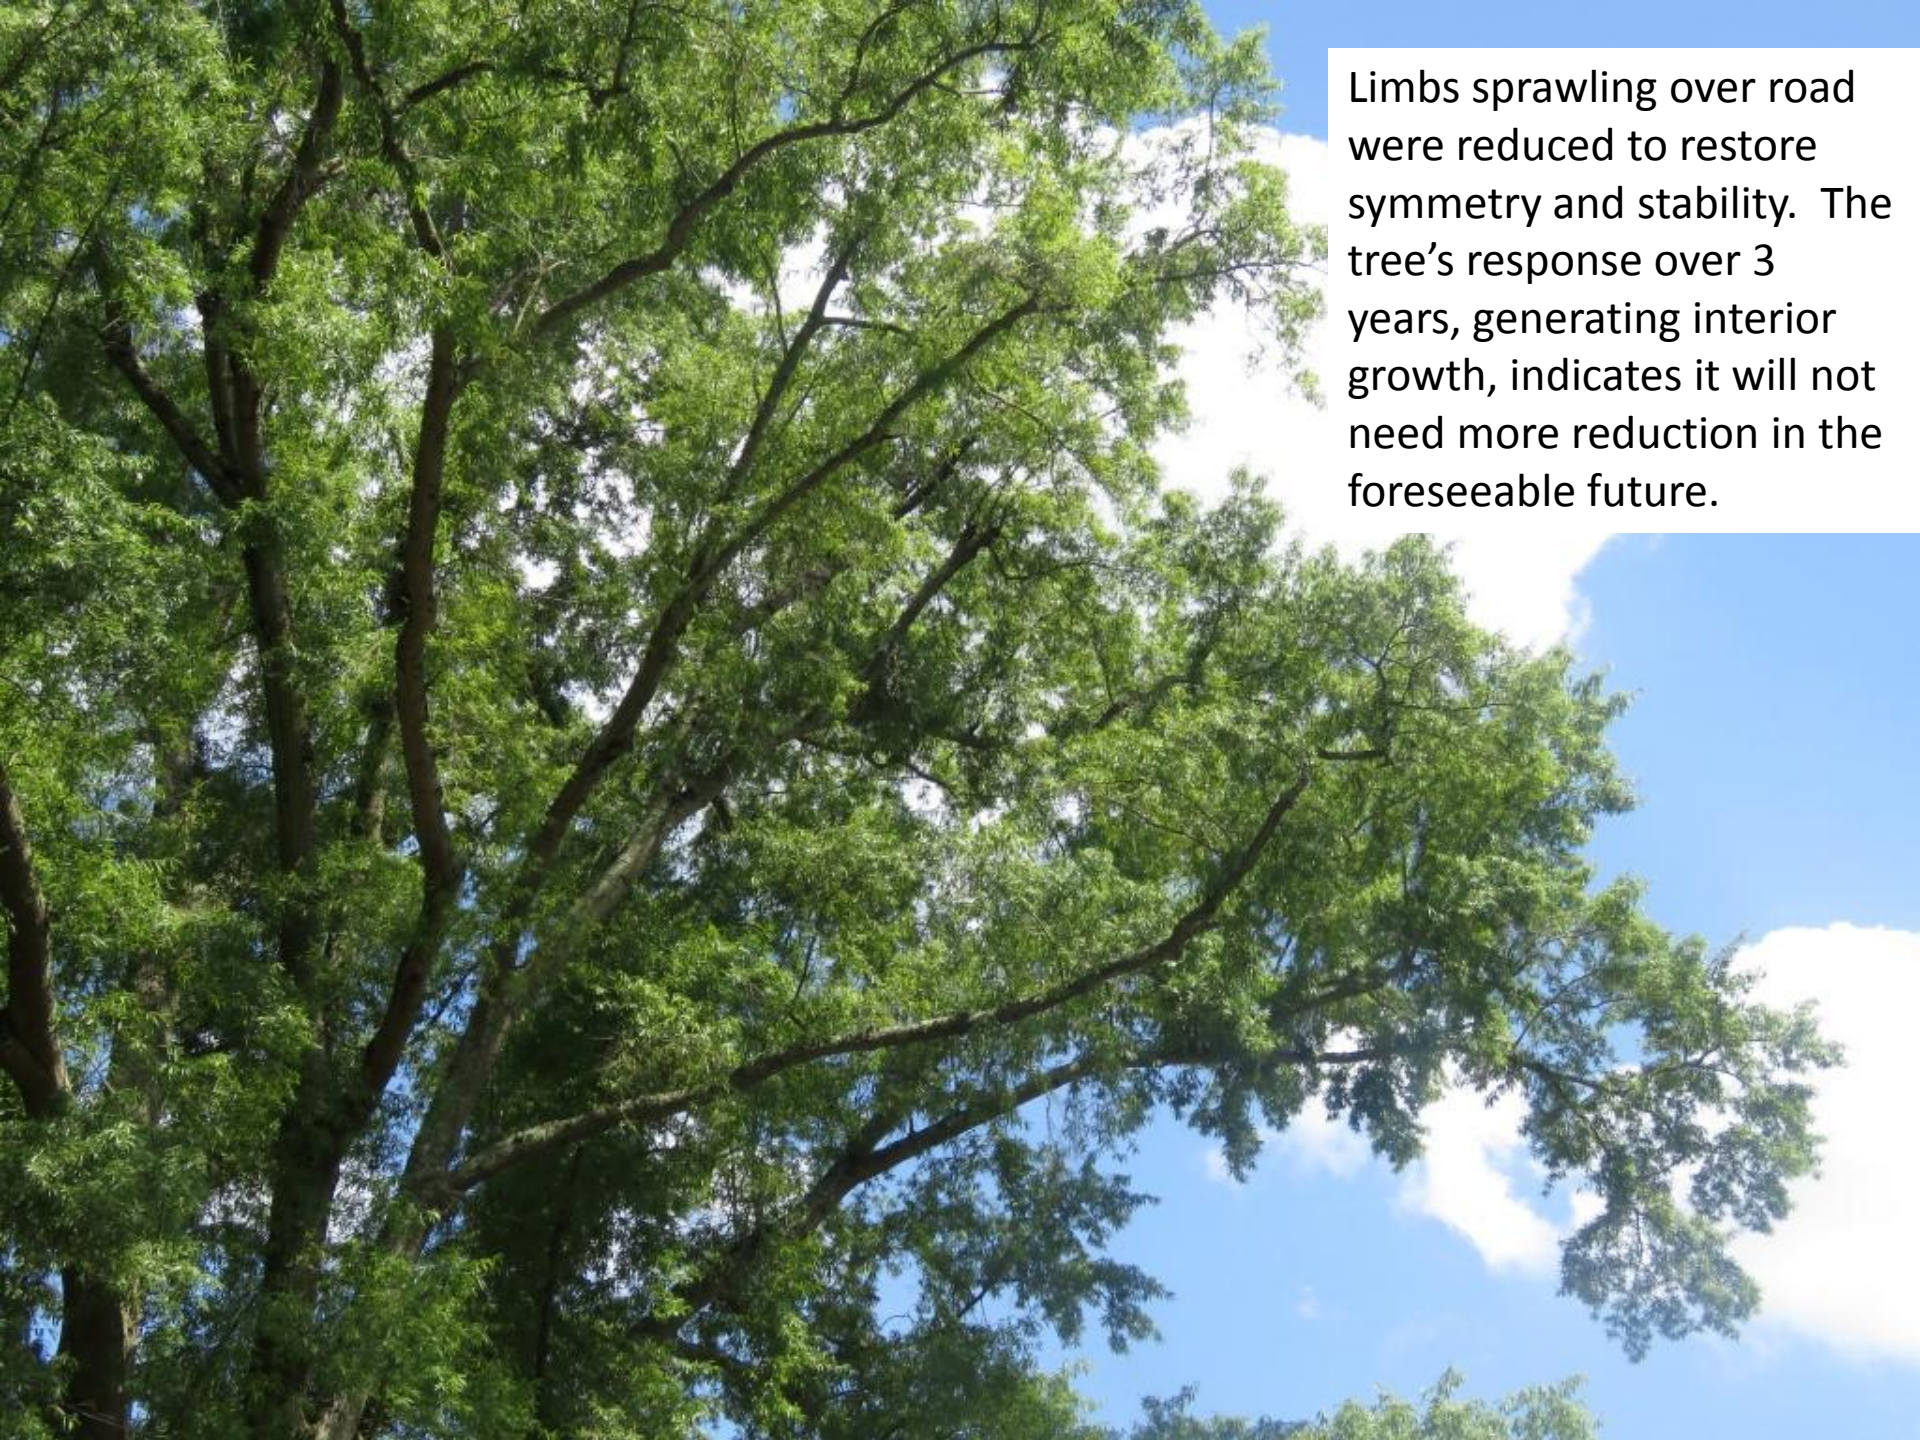
Limbs sprawling over road were reduced to restore symmetry and stability. The tree's response over 3 years, generating interior growth, indicates it will not need more reduction in the foreseeable future.

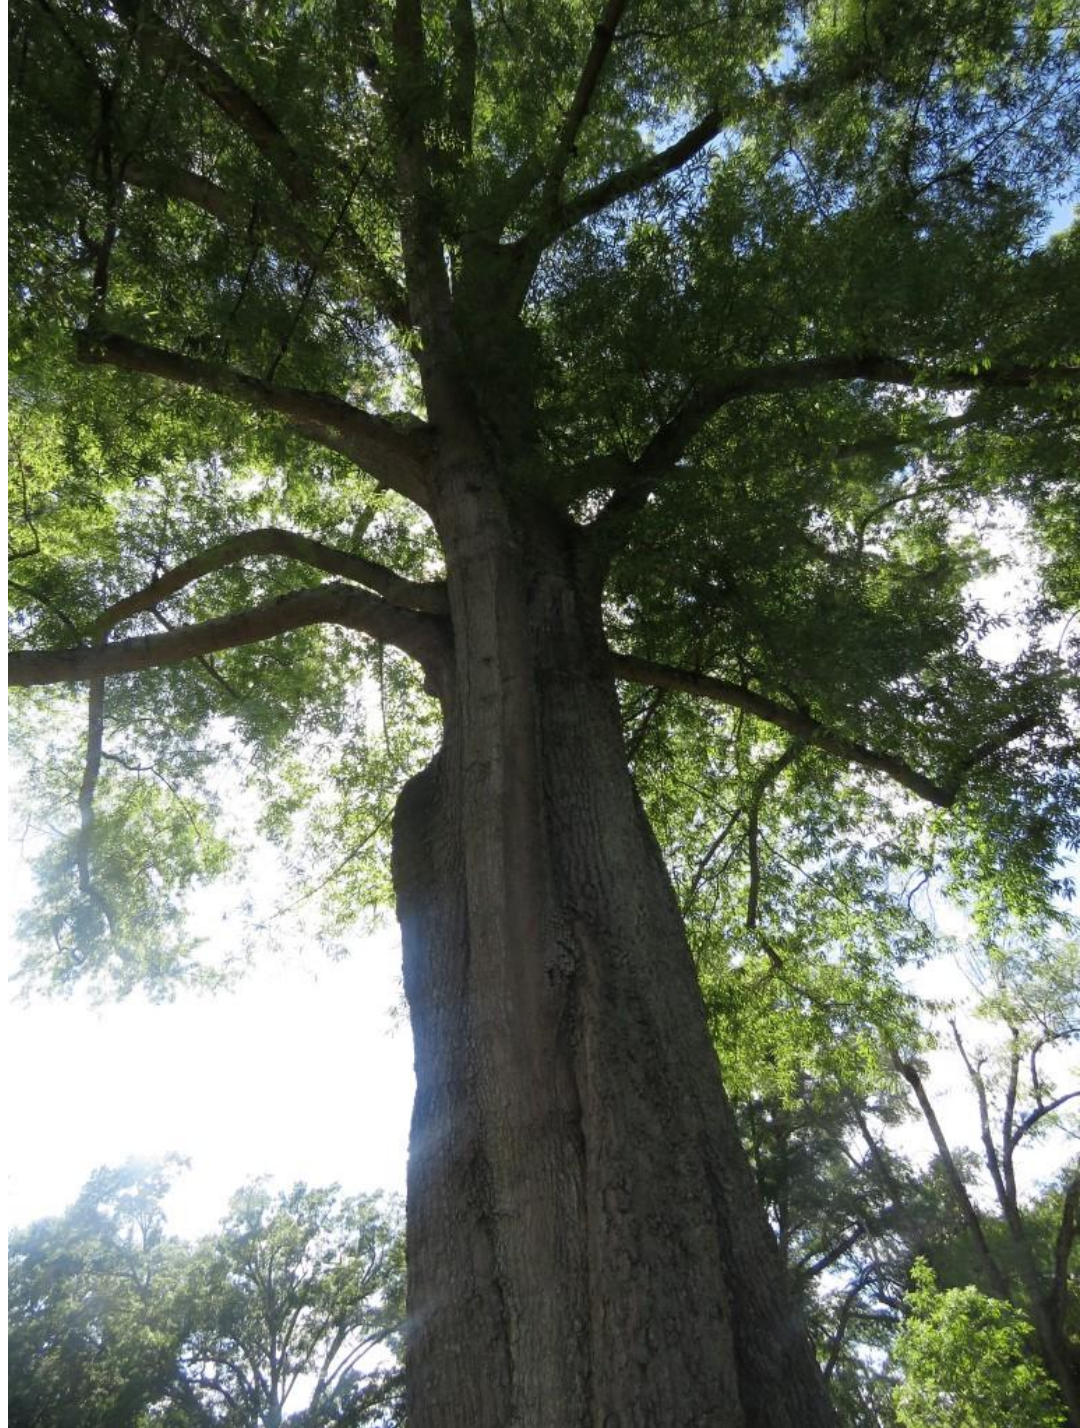
- 3 years after the top was reduced 10'-15', the natural form is restored.
- The base of the tree was not weakened.
- Limbs over the road were left to connect with the tree across the street.
- Continuous canopy is the goal.

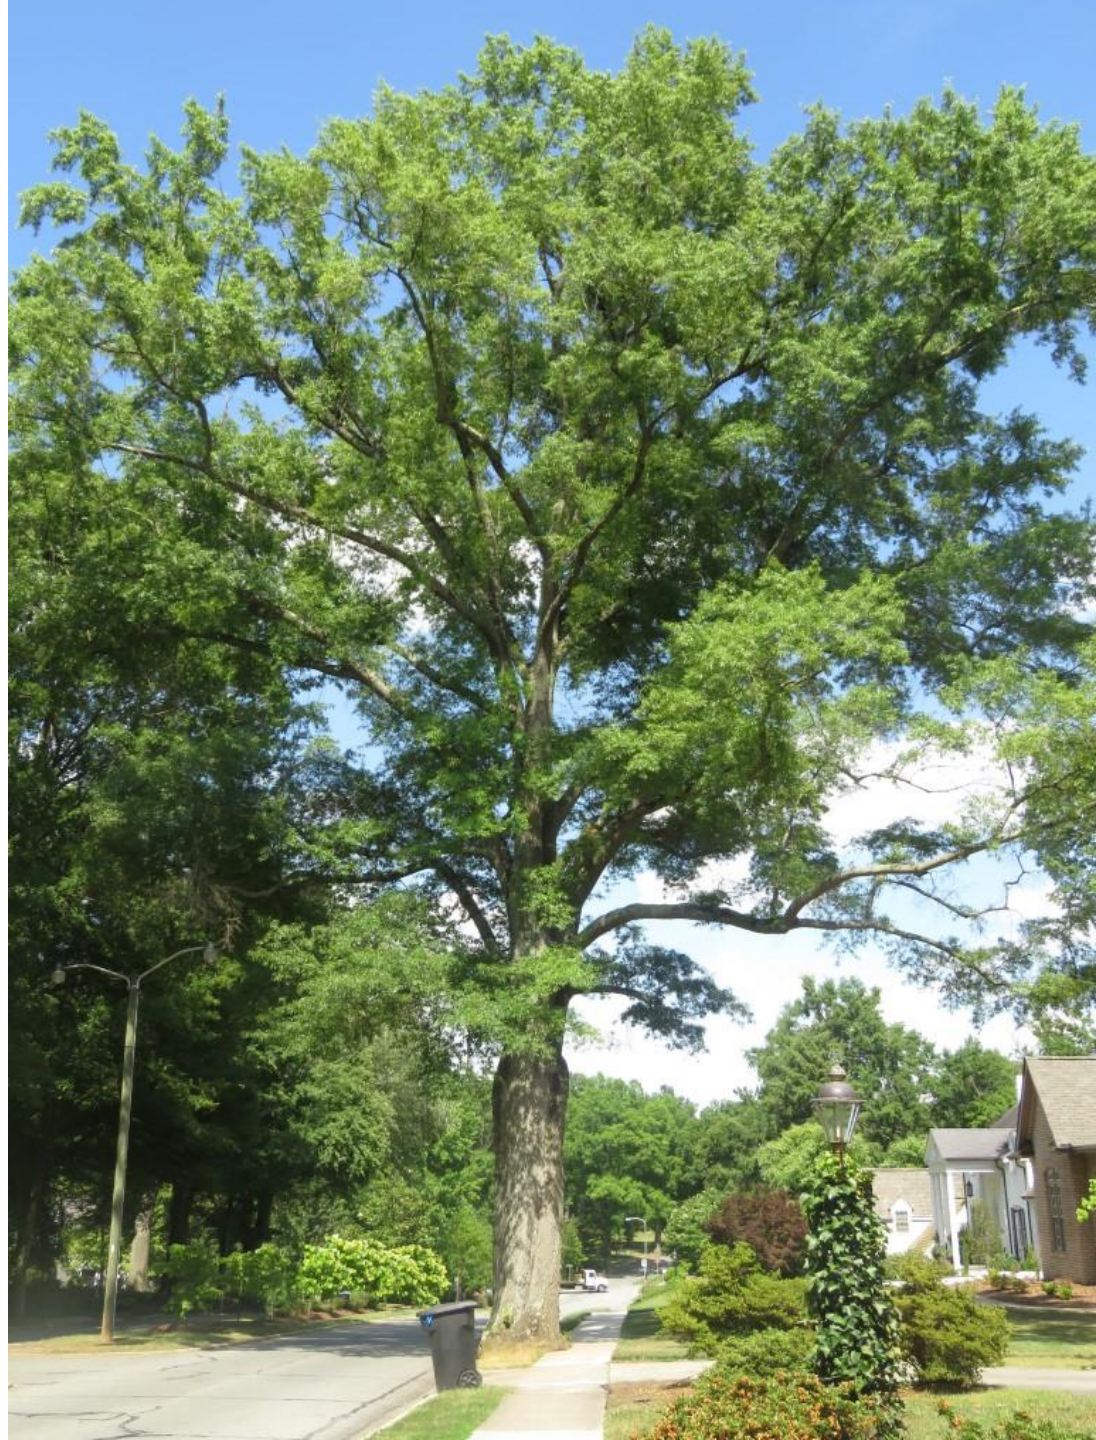
- “Elephant Ear” bulges indicate a codominant fork with included bark.
- Pruning lessens strain on this fork and resists splitting.
- Cabling is another option.

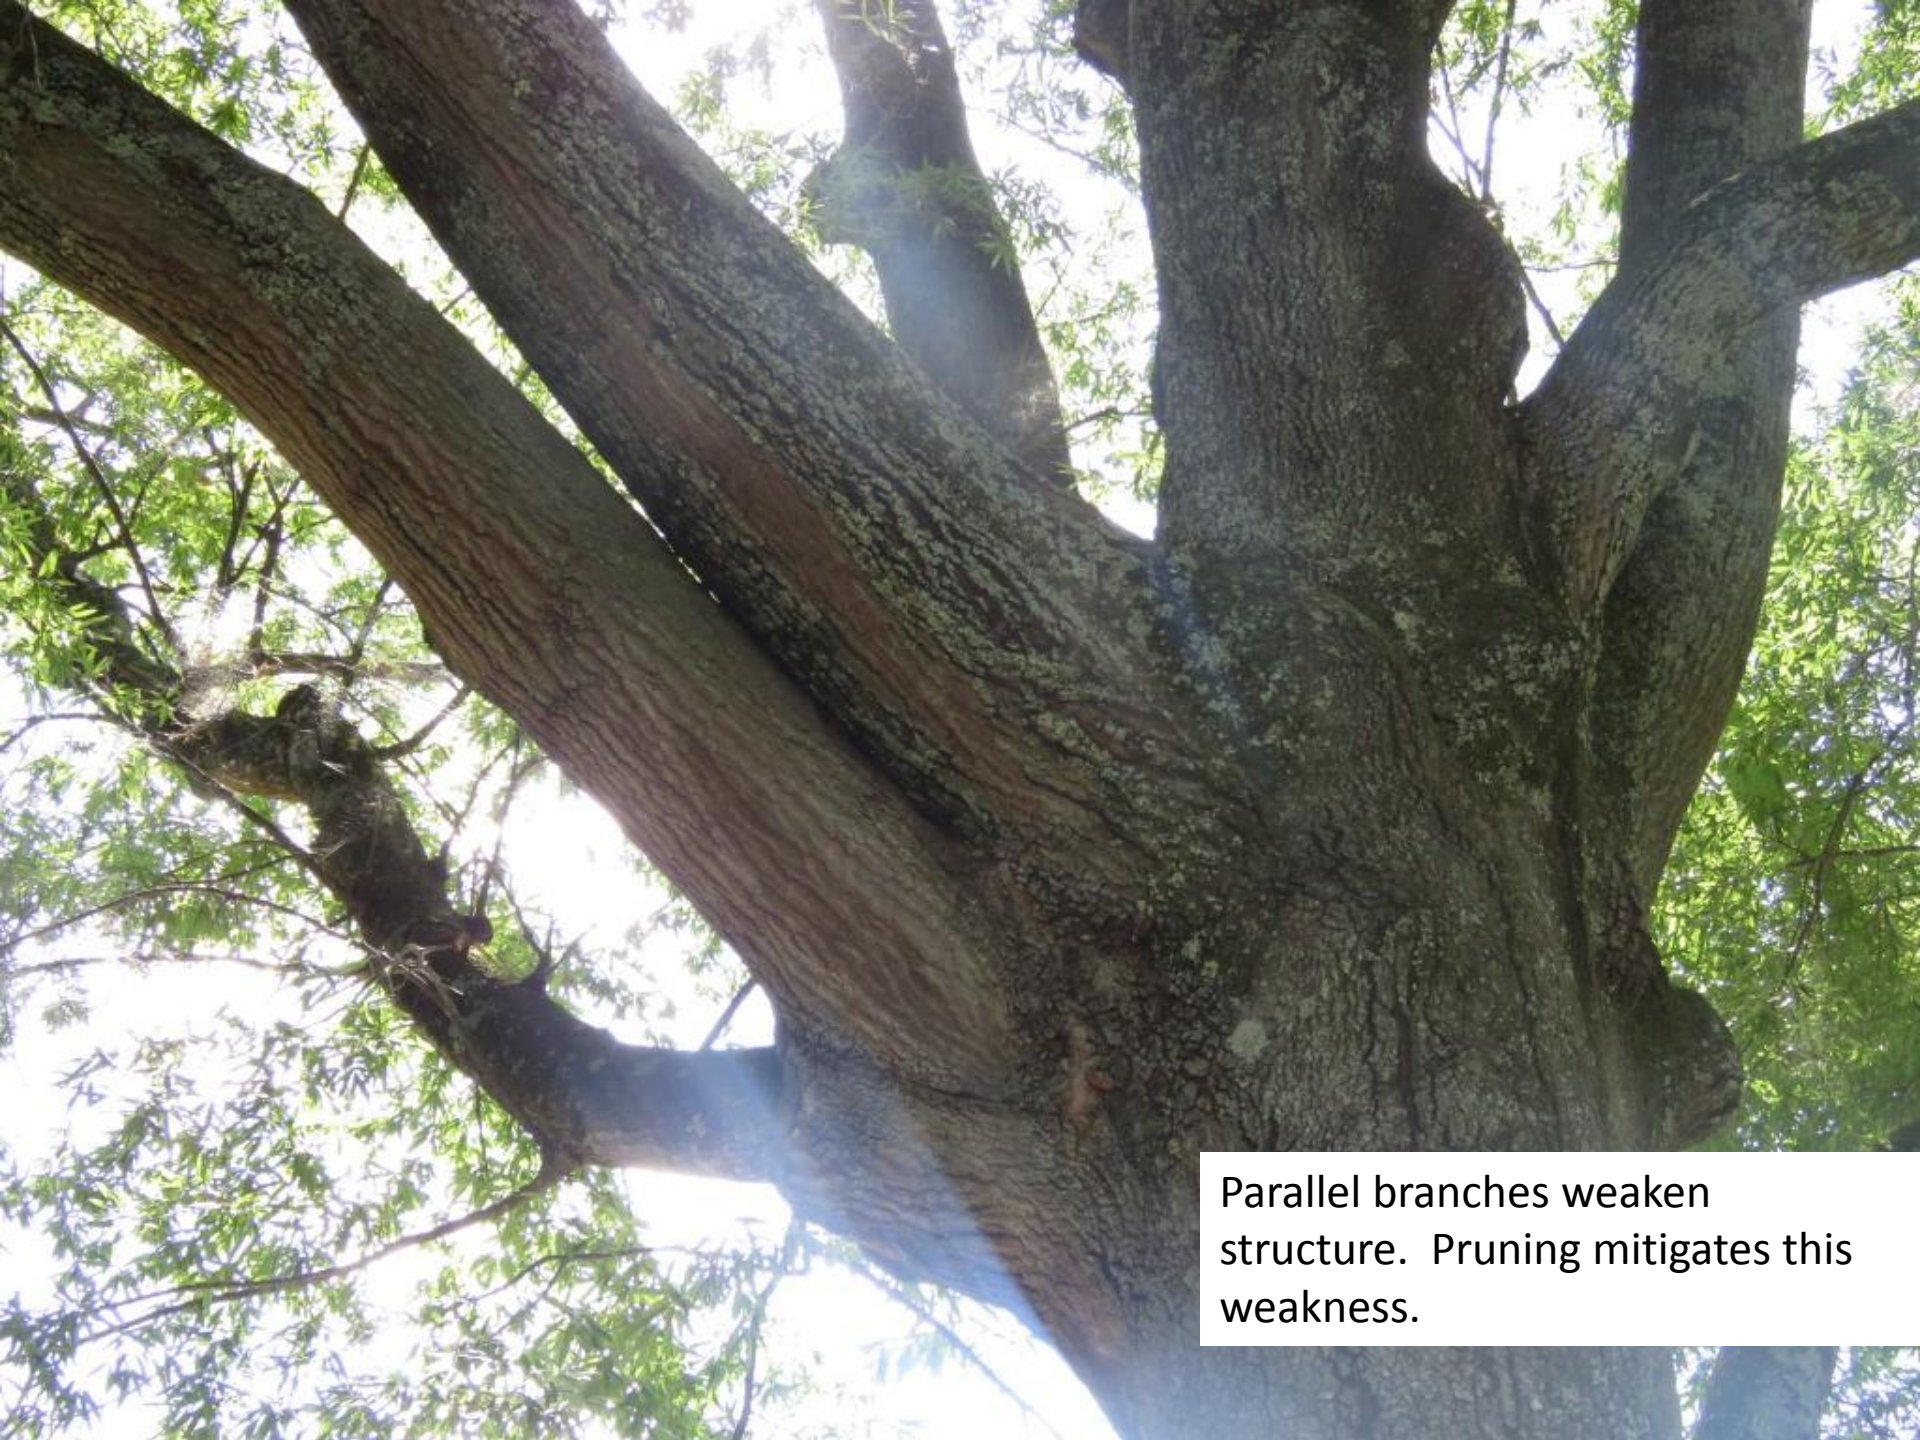
Parallel branches weaken structure. Pruning mitigates this weakness.

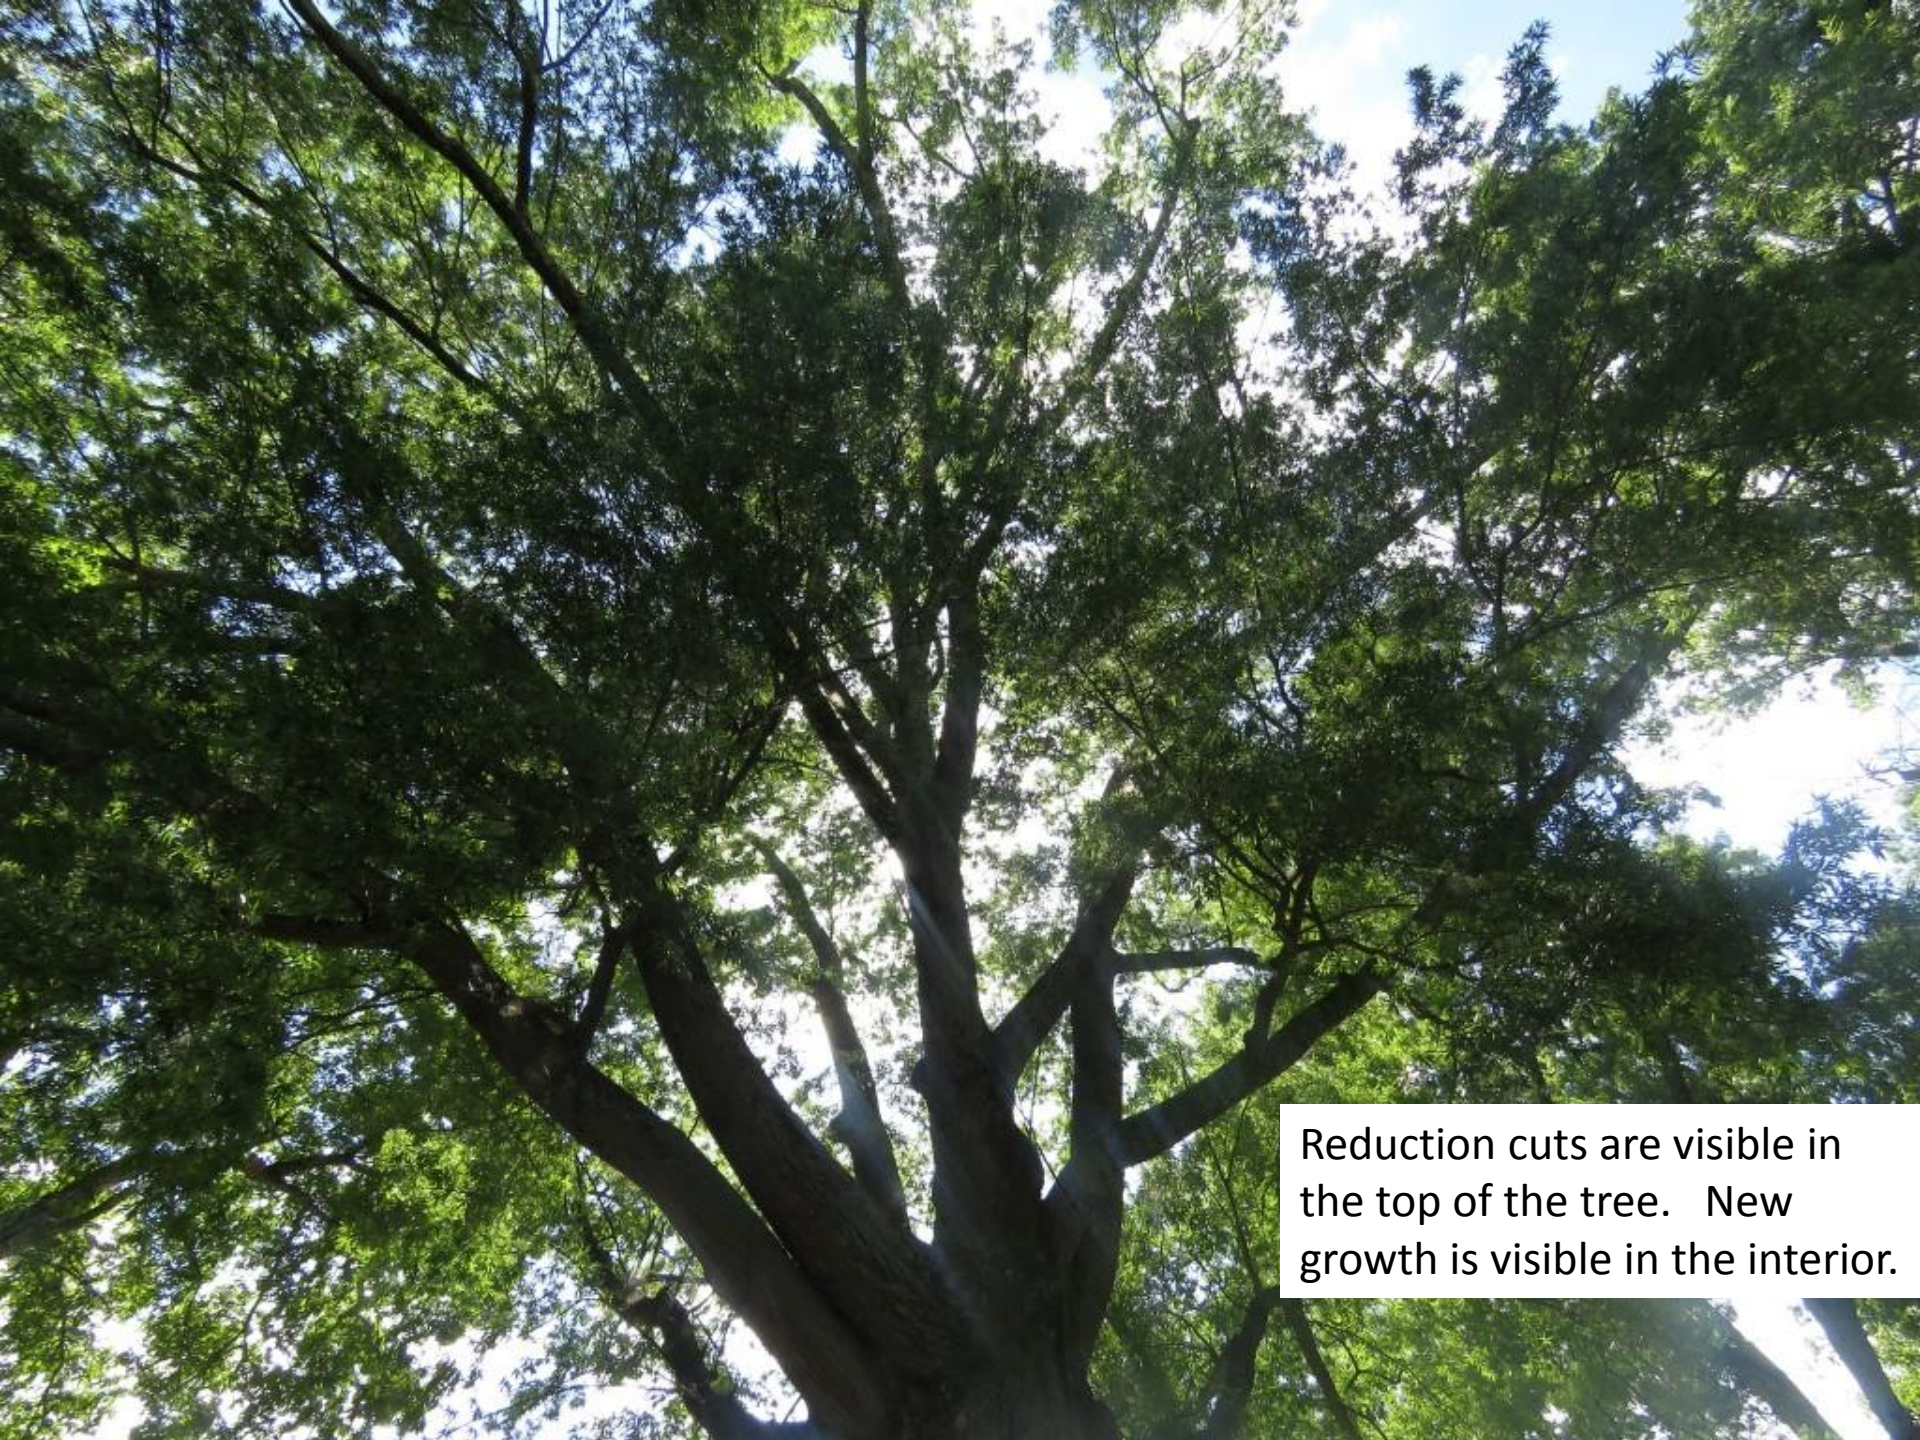
Reduction cuts are visible in the top of the tree. New growth is visible in the interior.
