**TreeCare, India**

Arboricultural Report**Root Extent Investigations and
Recommendations****Prepared For:**

Auroville Consulting
Saracon, Kottakarai, Irumbai,
Auroville, TN 605111, INDIA

31st of July 2017

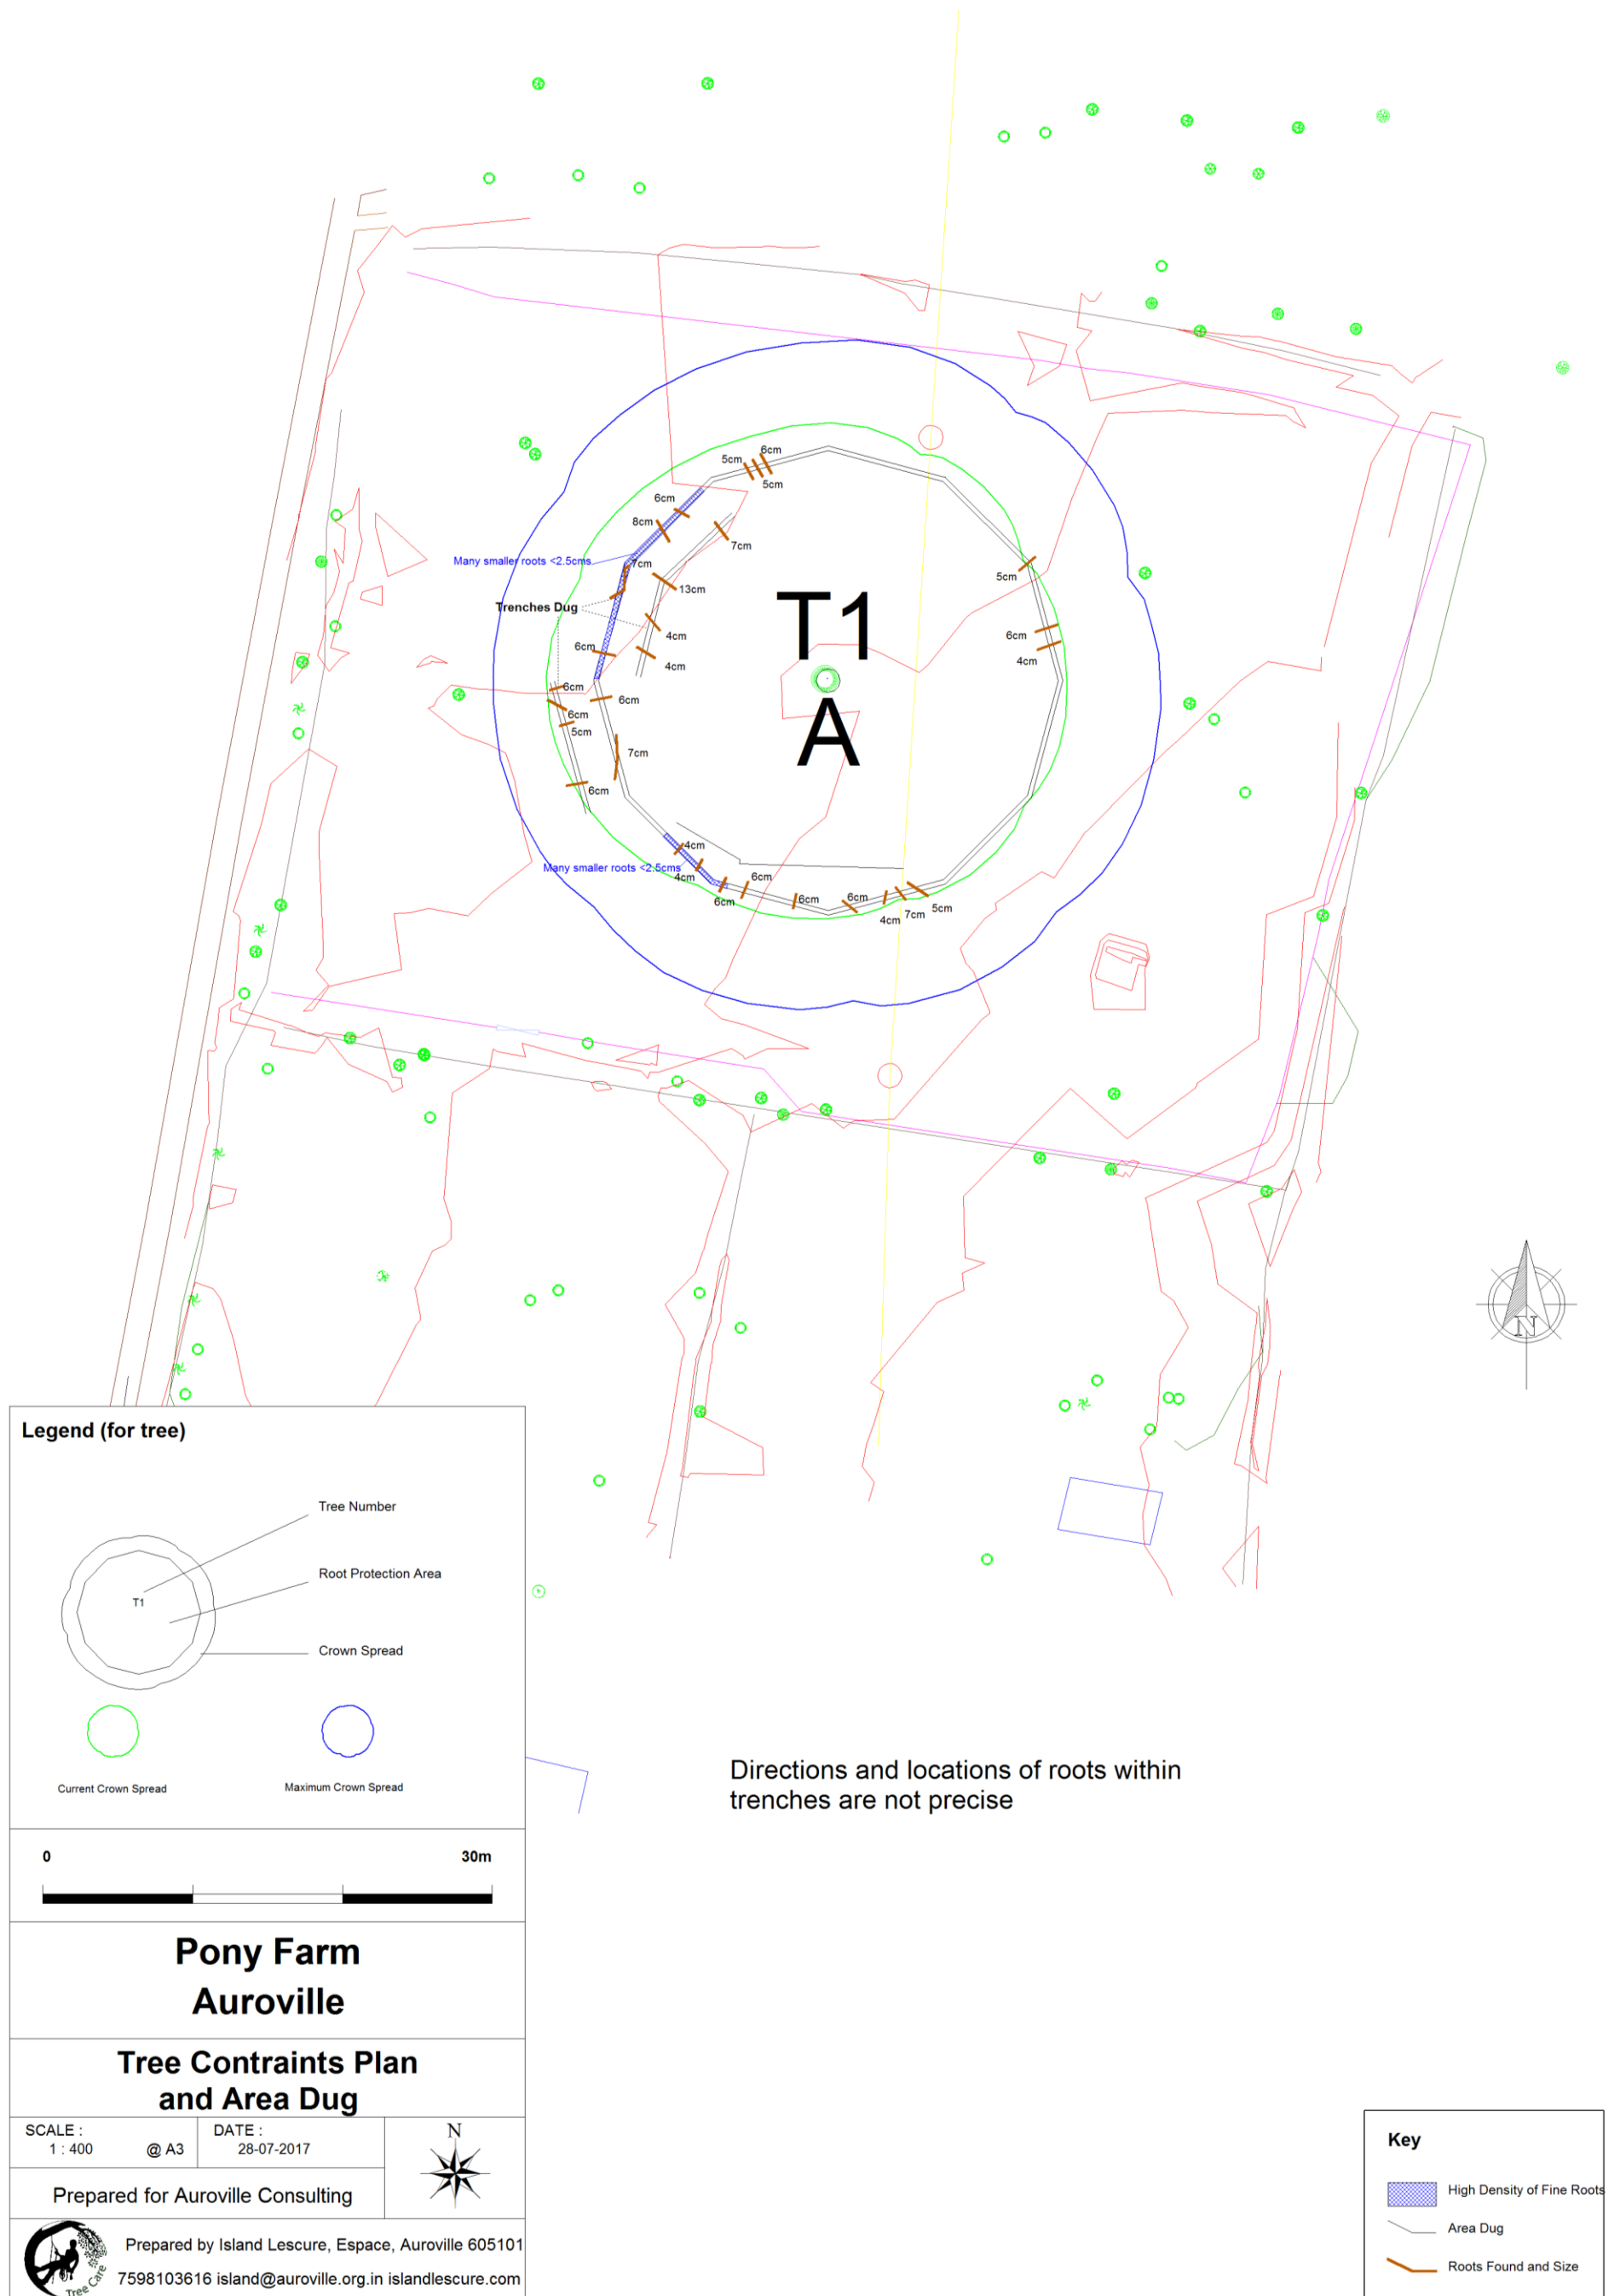
6 Appendix 1 - Tree constraints plan and area dug

- 2.5.1 A majority of the roots found were on the north-western side to the southern side following an anti-clockwise direction. This follows the layout of the land as this area is on the lower slope and therefore collects more water and nutrients during rains. Root growth will also be affected by the density of the soil; the area where few roots are present, little to no other vegetation is present.
- 2.5.2 All visible roots of 4cms and above have been plotted approximately on the attached plan (appendix 1). Where high densities of roots were found, it has also been indicated on the plan.
- 2.5.3 Very few roots were found to the east and north.

- 3.1.1 Excavating at a minimum of 14 meters away from the trunk on the northern side
- 3.1.2 Excavating at a minimum of 17 meters away from the trunk on the north-western side to the southern side following an anti-clockwise direction

- 3.1.3 Excavating at a minimum of 13 meters (~15% less than RPA) away from the trunk on the south-eastern to the north-eastern side following an anti-clockwise direction if the total RPA in area is retained (707m²)

- 3.1.4 Although the root system is mostly from the north-western side to the southern side following an anti-clockwise direction, any digging within 15 meters from the trunk should be done by hand. Any potential construction or installation of services within this zone should employ appropriate engineering solutions to mitigate root loss through direct damage, compaction etc...

- 3.1.5 When Excavating by mechanical means (e.g. JCB) within 17 meters of the trunk, area to be dug is to be 50cms from final distance away from trunk (if the trench is required at 16 meters from the trunk, the trench is to be dug at 17.5 meters from the trunk) this will allow access to dig to the limit by hand and prune the roots that require it (the roots will be exposed and easy to dig around to prune back to the required distance).
