# Managing Mature Trees

- West Davis Street in Burlington is lined with willow oak trees planted ~80 years ago.
- One tree fell over in a storm, so the City looked at management options.
- 3 trees were removed, and 35 were reduced by specified pruning methods.
- 3 years later, 34 of those trees are doing well. No pruning is needed in the near future.

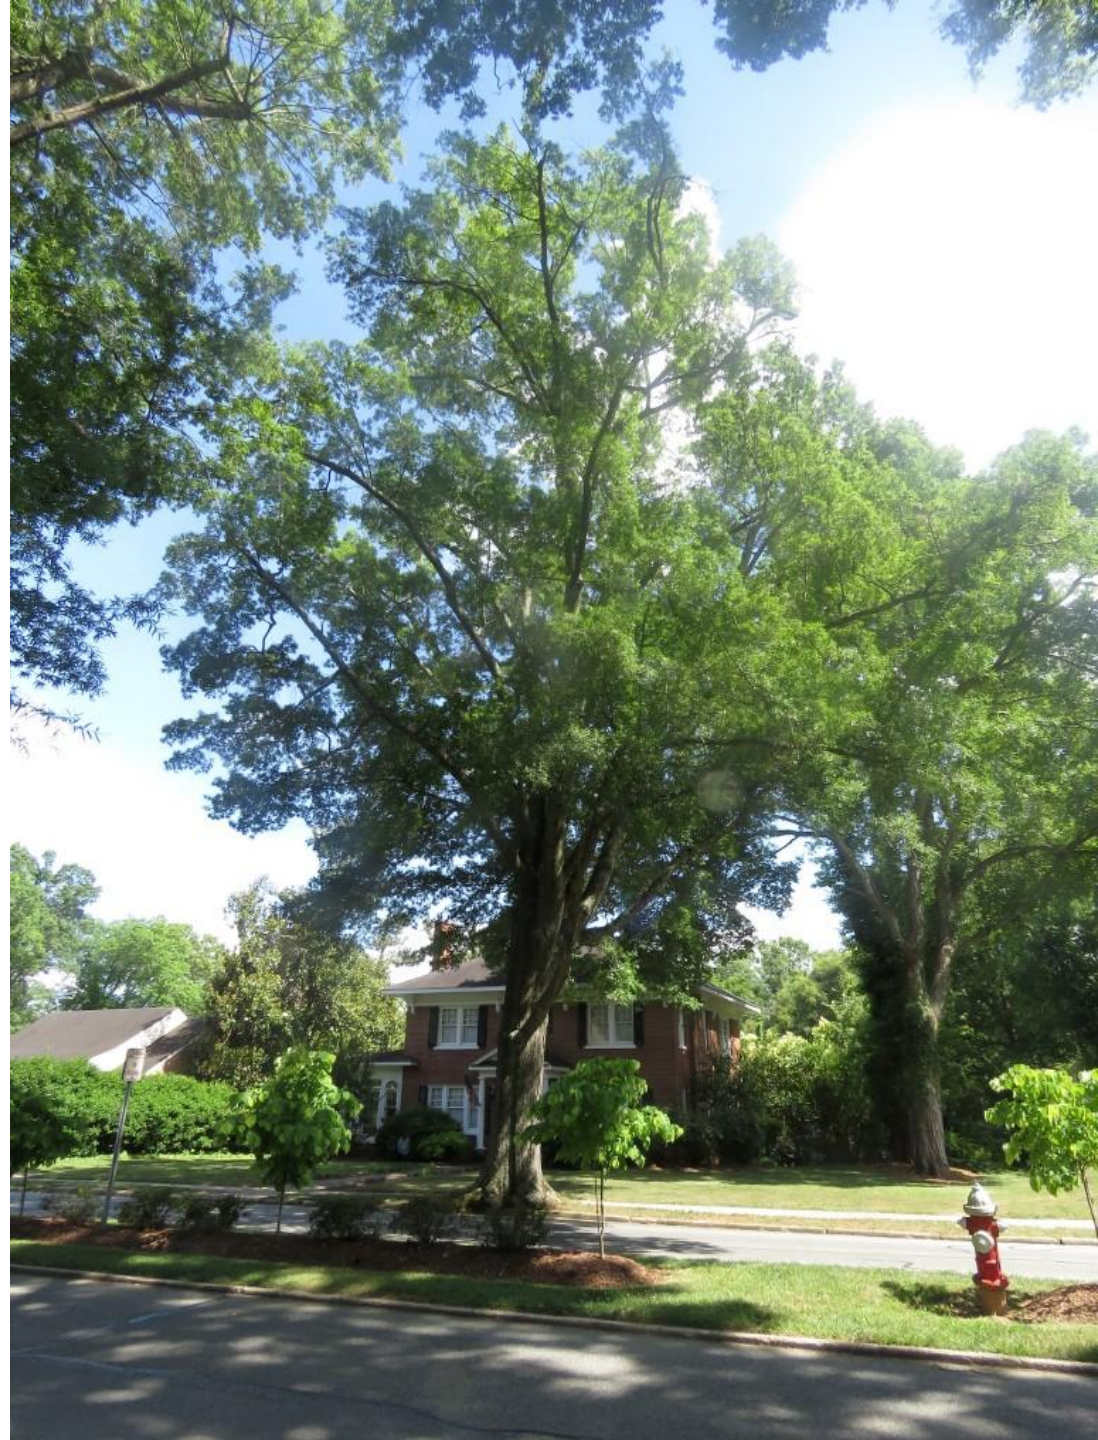
- Pruning retained much of the trees' volume and benefits.

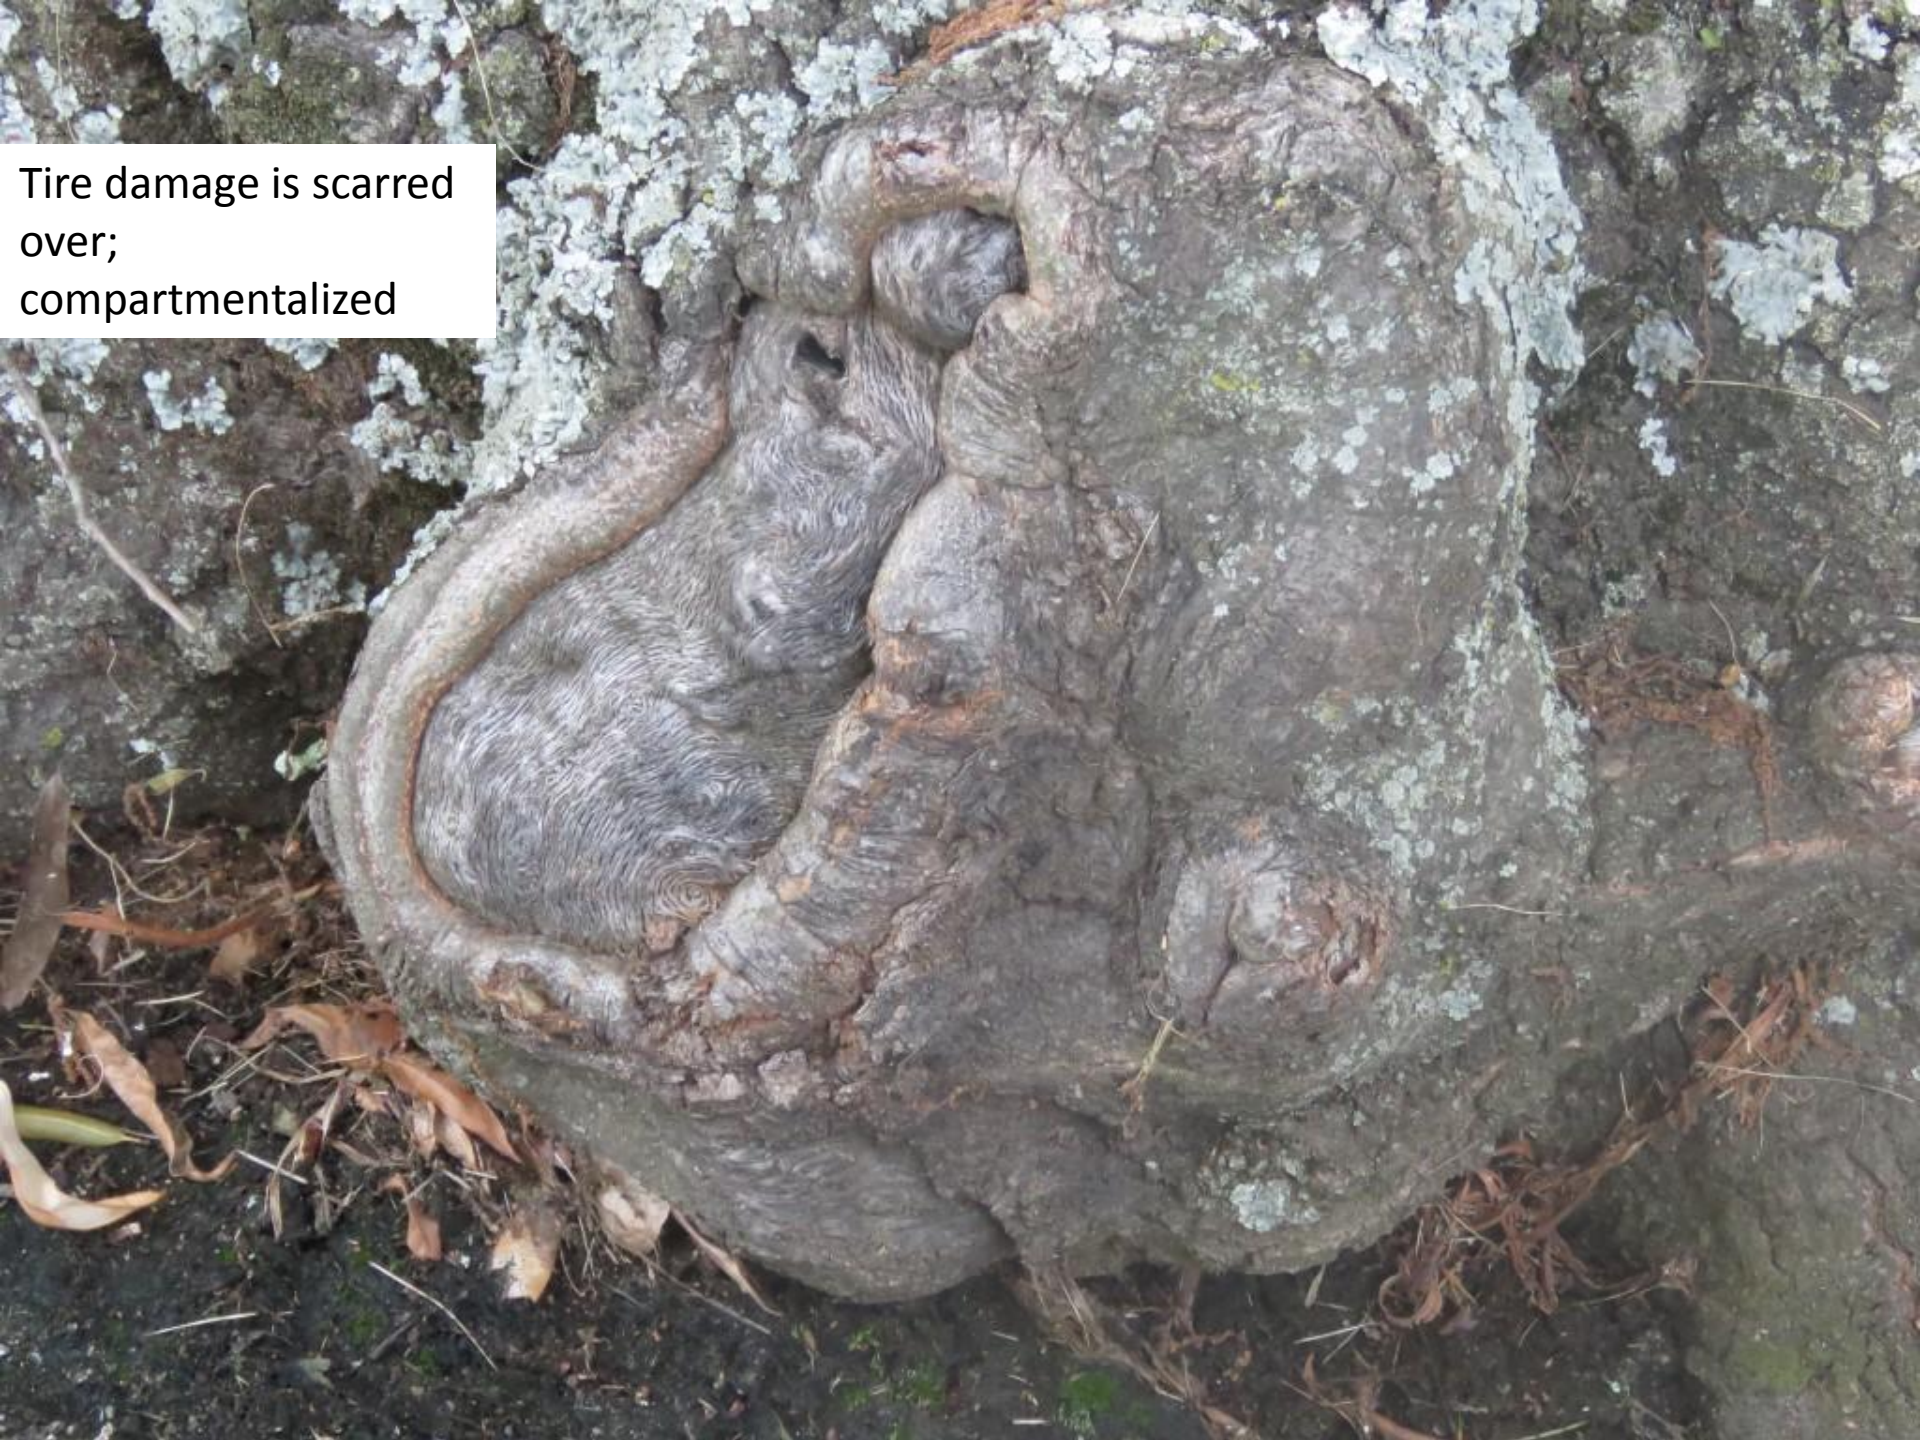
The flare spreads over the curb, and replaces it.

Tire damage is scarred  
over;  
compartmentalized

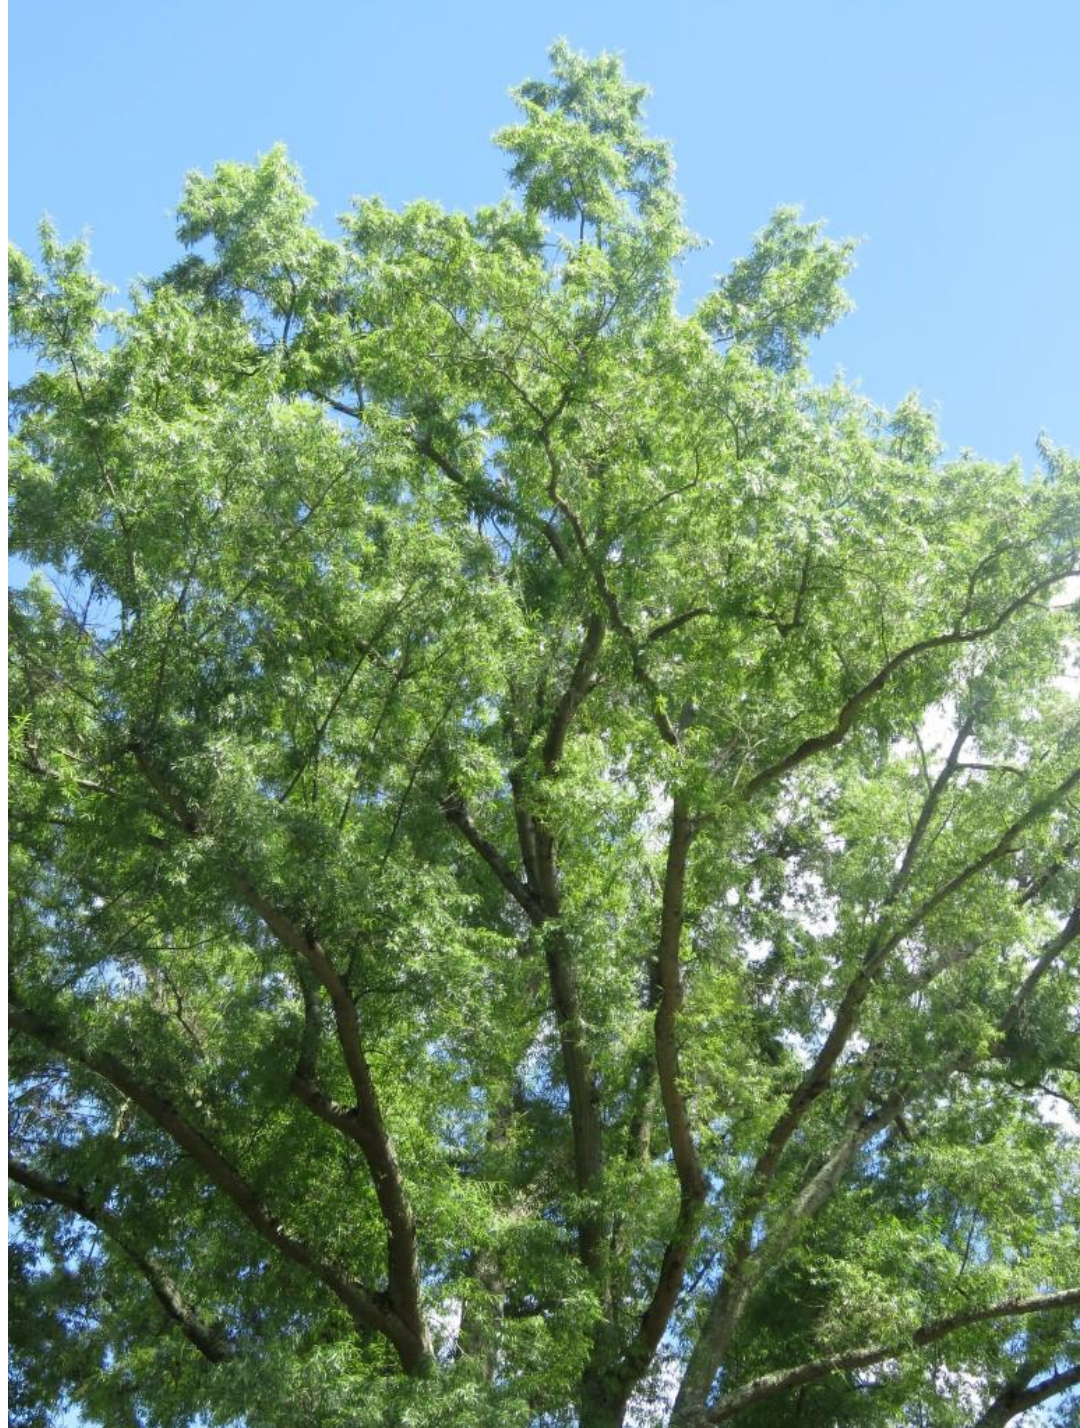
- Small cuts on the outside stimulates new growth on the inside.
- Reduction pruning causes trees to 'grow downward'.

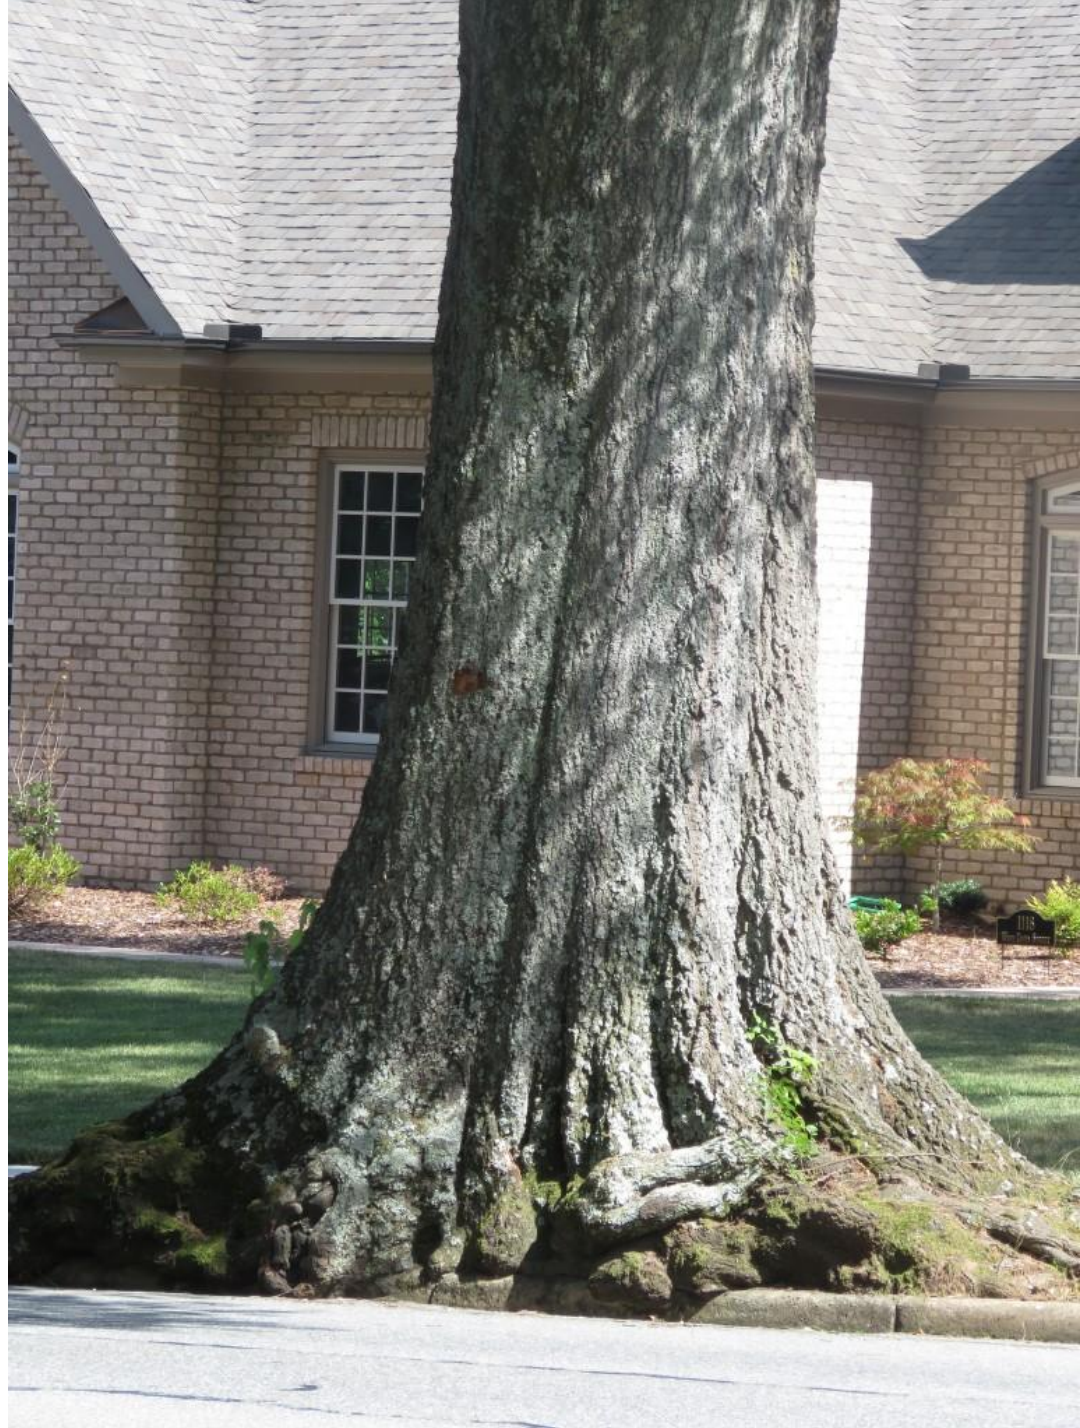
- The flare gets broader, adding stability.
- If the roots are not damaged by work on curbs and sidewalks, support is retained.
- If the load in the crown is reduced, the tree's useful life is extended indefinitely.

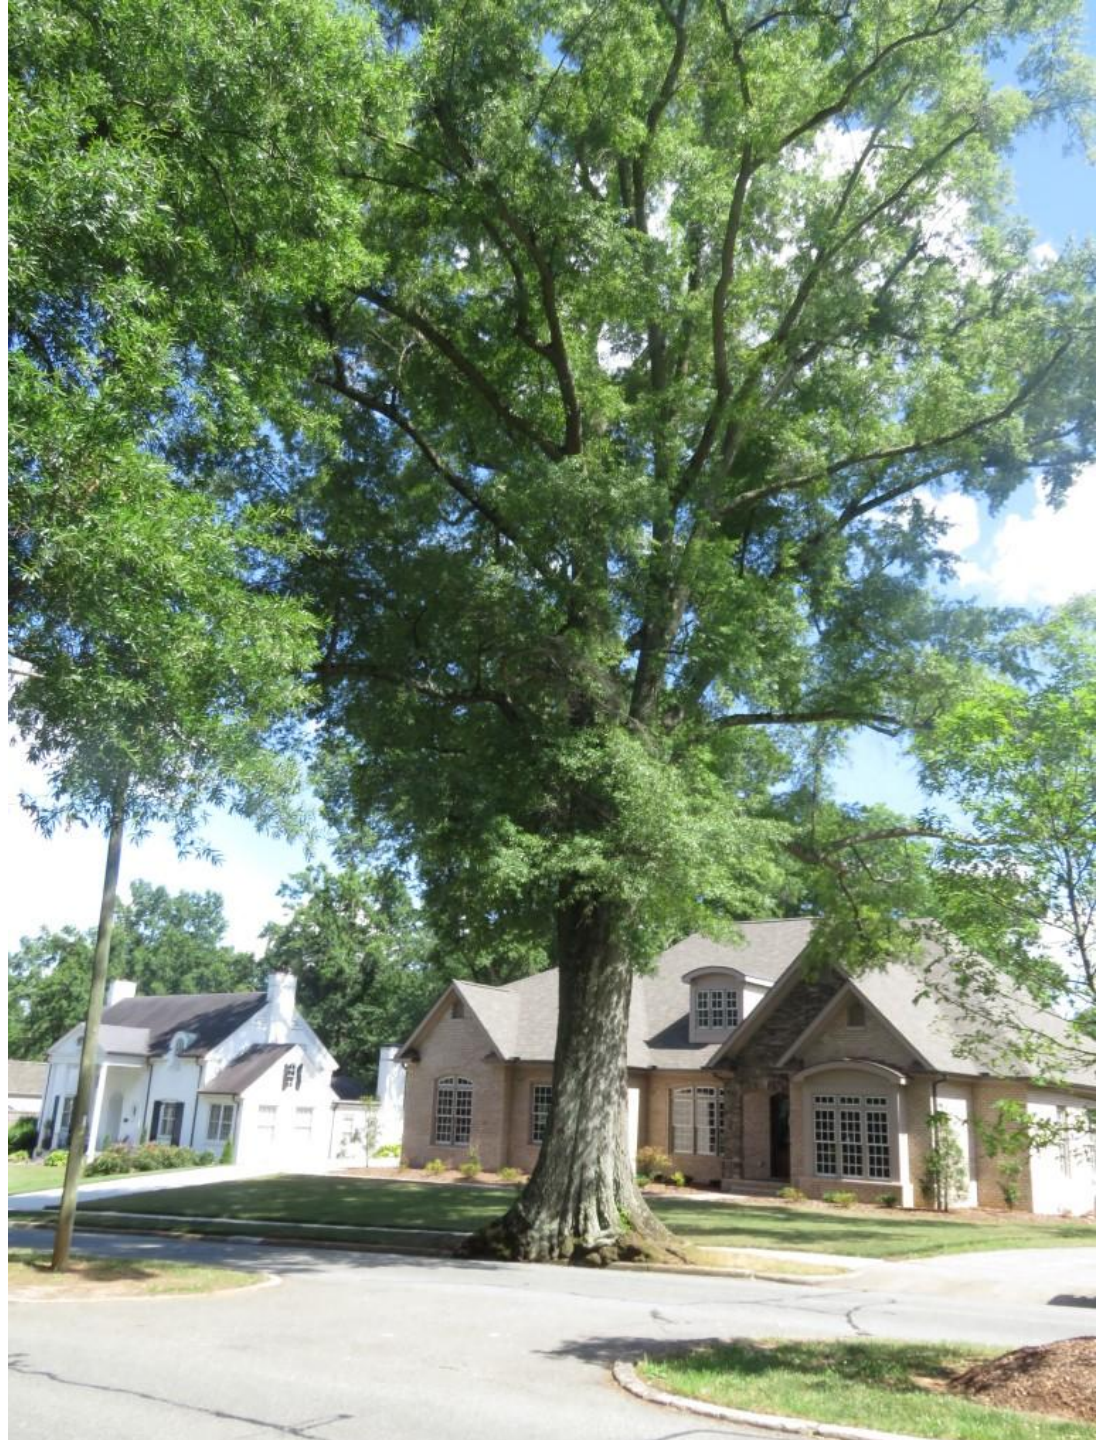
- A typical tree on this street: 90 feet tall and 90 years old, with a potential 90 or more left to go.
- Lower branches are retained. The trunk gets thicker, and the center of gravity is lowered by new interior growth.

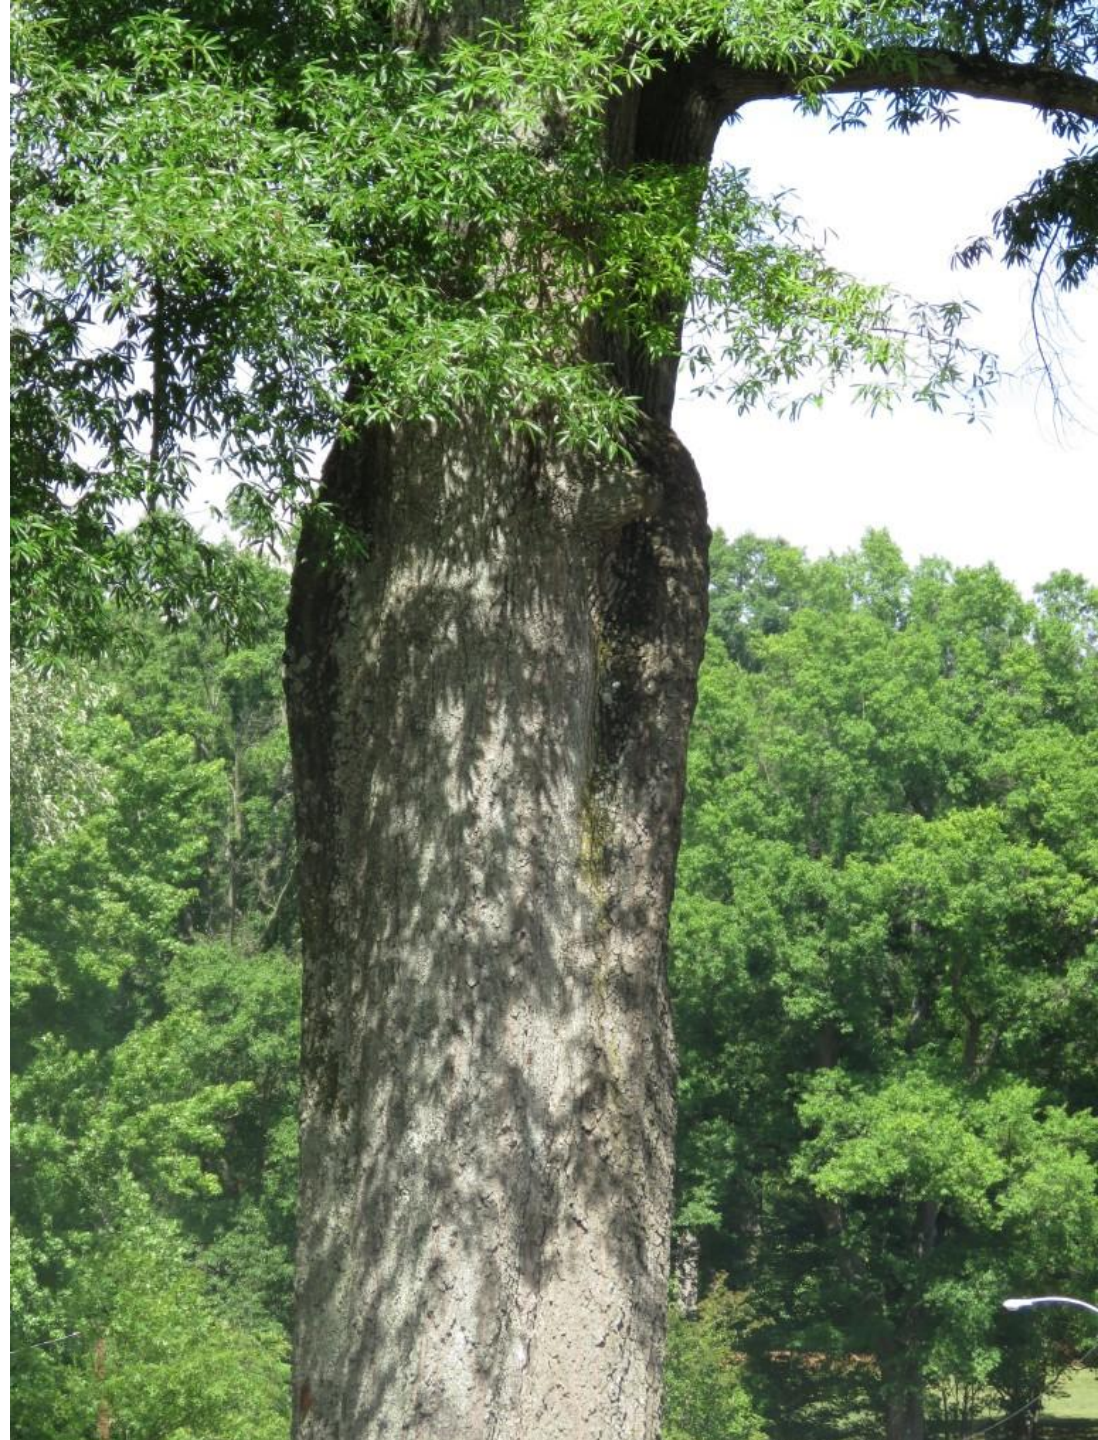
- “Elephant Ear” bulges indicate a codominant fork with included bark.
- Pruning lessens strain on this fork and resists splitting.
- Cabling is another option.

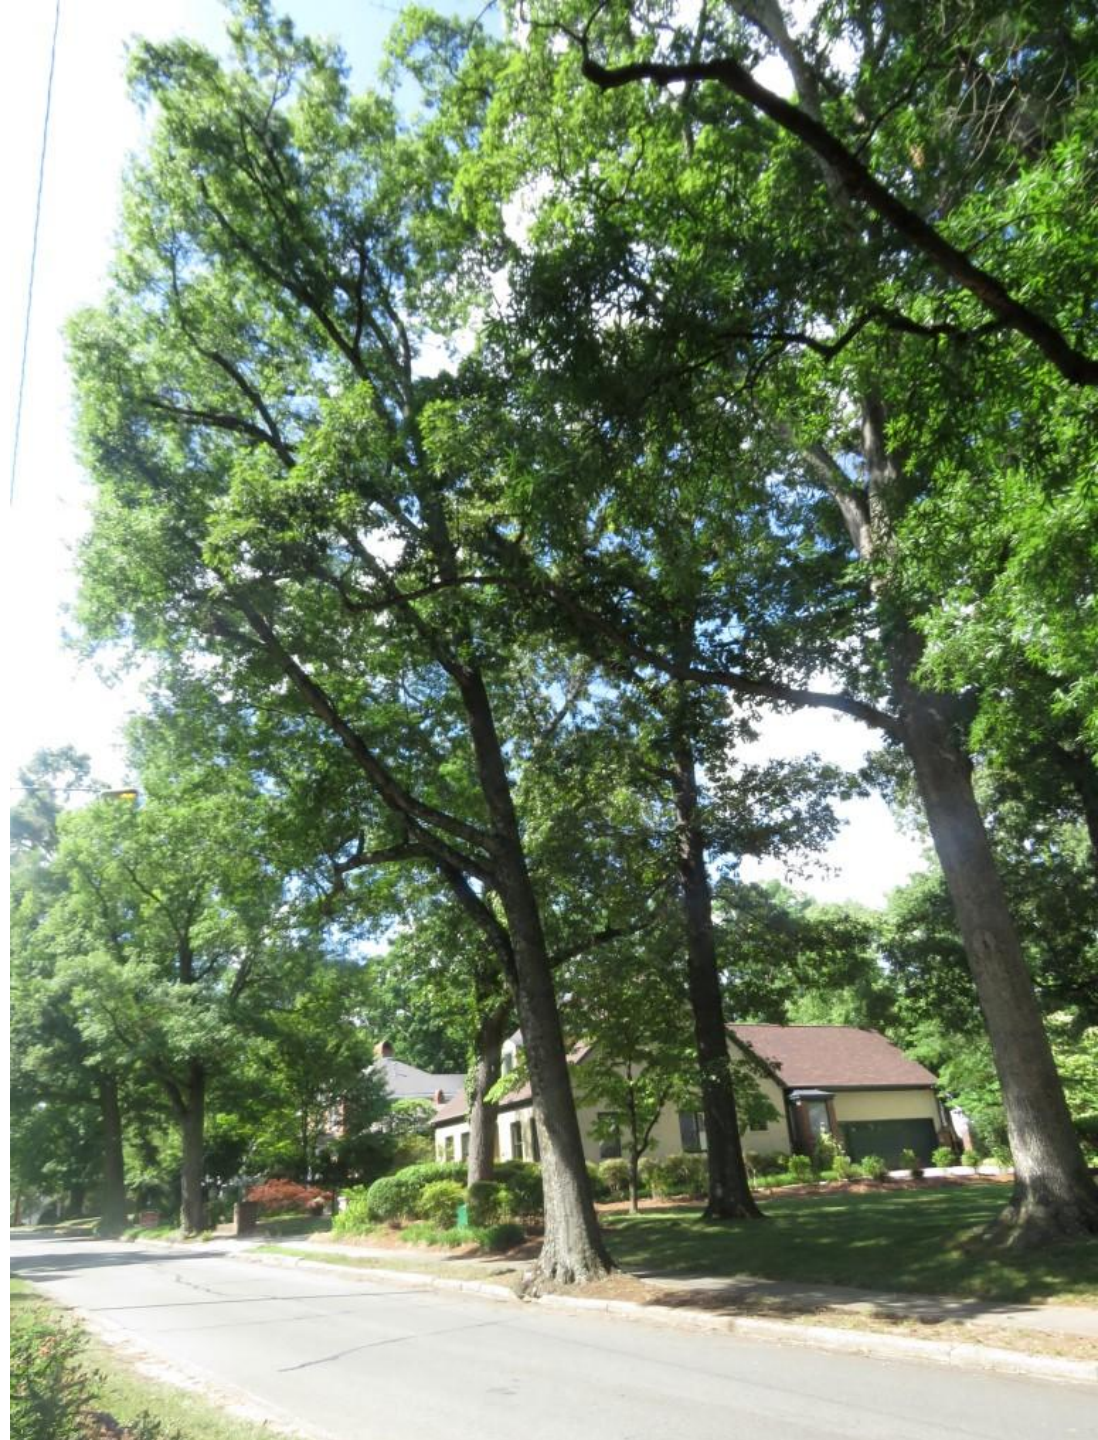
- Trees naturally spread into open areas over roads and houses.
- Routine pruning limits sprawl and risk of failure.
- Long-term clearance is gained by a small input of resources.
